FINAL REPORT Subsurface Investigation for Structural Integrity Study of Aircraft Ramp at Hanger 4802 NASA Armstrong Flight Research Center Edwards, California

**SUBSURFACE INVESTIGATION REPORT
FOR
STRUCTURAL INTEGRITY STUDY OF
AIRCRAFT RAMP AT HANGER 4802
NASA ARMSTRONG FLIGHT RESEARCH CENTER
EDWARDS, CALIFORNIA**

Final Report: June 9, 2016

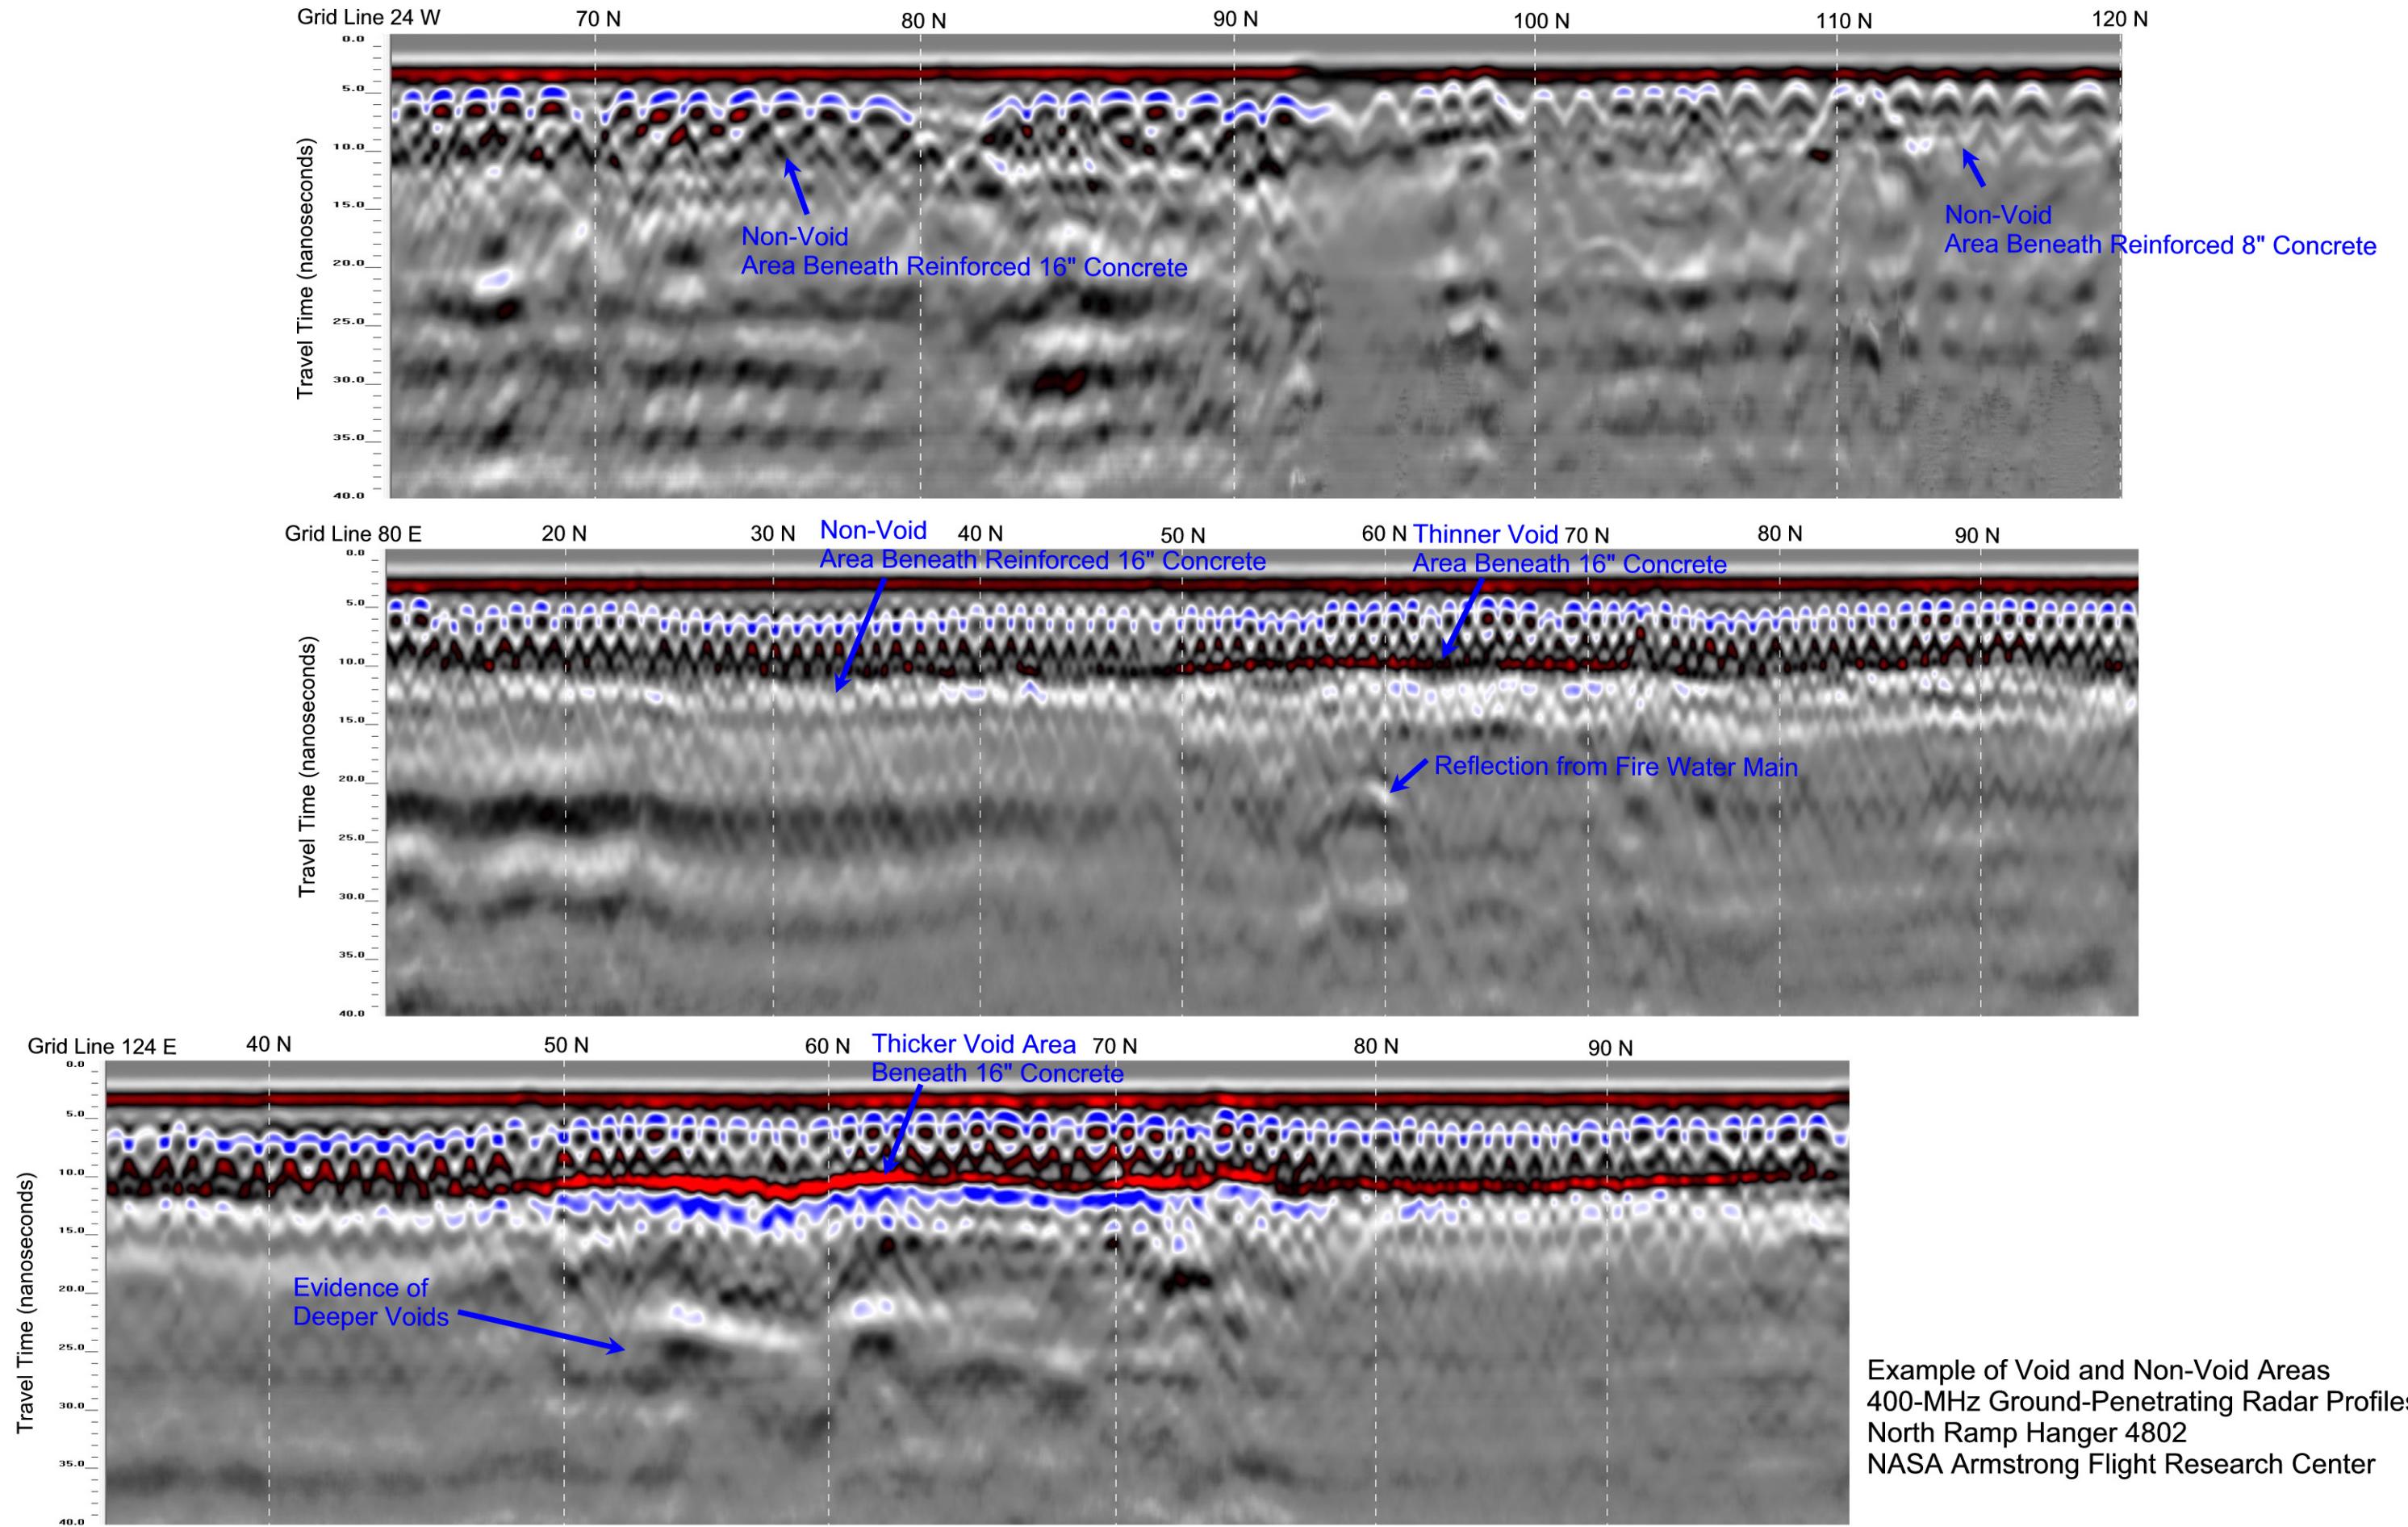
Past experience with GPR investigations for subsurface voids demonstrates that anomalous, higher-amplitude reflections occur near the expected concrete-ground interface where a measureable air-space void exists below this interface. Deeper voids and porous conditions within the sub-grade soils often show more chaotic reflection patterns from the normal layered subsurface reflection patterns. The areas where we interpreted these anomalous reflection patterns indicating subsurface voids are delineated on the site grid map shown in Plate 1. Figure 2 displays selected GPR profiles across areas where we interpreted various void and non-void conditions. The correlation of these GPR profiles to future core hole measurements of void conditions would allow us to make a thickness evaluation of these void spaces beneath the ramp area.

Evidence of void spaces was first detected beneath the concrete pavement of the Hanger 4802 north ramp during the field investigation as the ground-penetrating radar (GPR) profiles were recorded across the area surrounding the main break in the fire main. Patterns of anomalous, higher-amplitude reflections (displayed in Figure 2) were observed on the GPR profiles across this area where the reflection pattern from the concrete-ground interface was expected.

After the GPR profiles underwent computer processing and color-amplitude display in our office these anomalous reflection patterns were more visible across the ramp area. An evaluation was made of the GPR profiles recorded across the ramp to identify and map out anomalous reflection patterns indicating evidence of voids. The site grid map in Plate 1 presents this mapping and also shows areas where the strongest amplitude reflection patterns indicate thicker void spaces beneath the pavement. As expected, this mapping shows thicker void spaces beneath the 16-inch concrete pavement in the area surrounding the main break point.

Example of Void and Non-Void Areas
400-MHz Ground-Penetrating Radar Profiles
North Ramp Hanger 4802
NASA Armstrong Flight Research Center

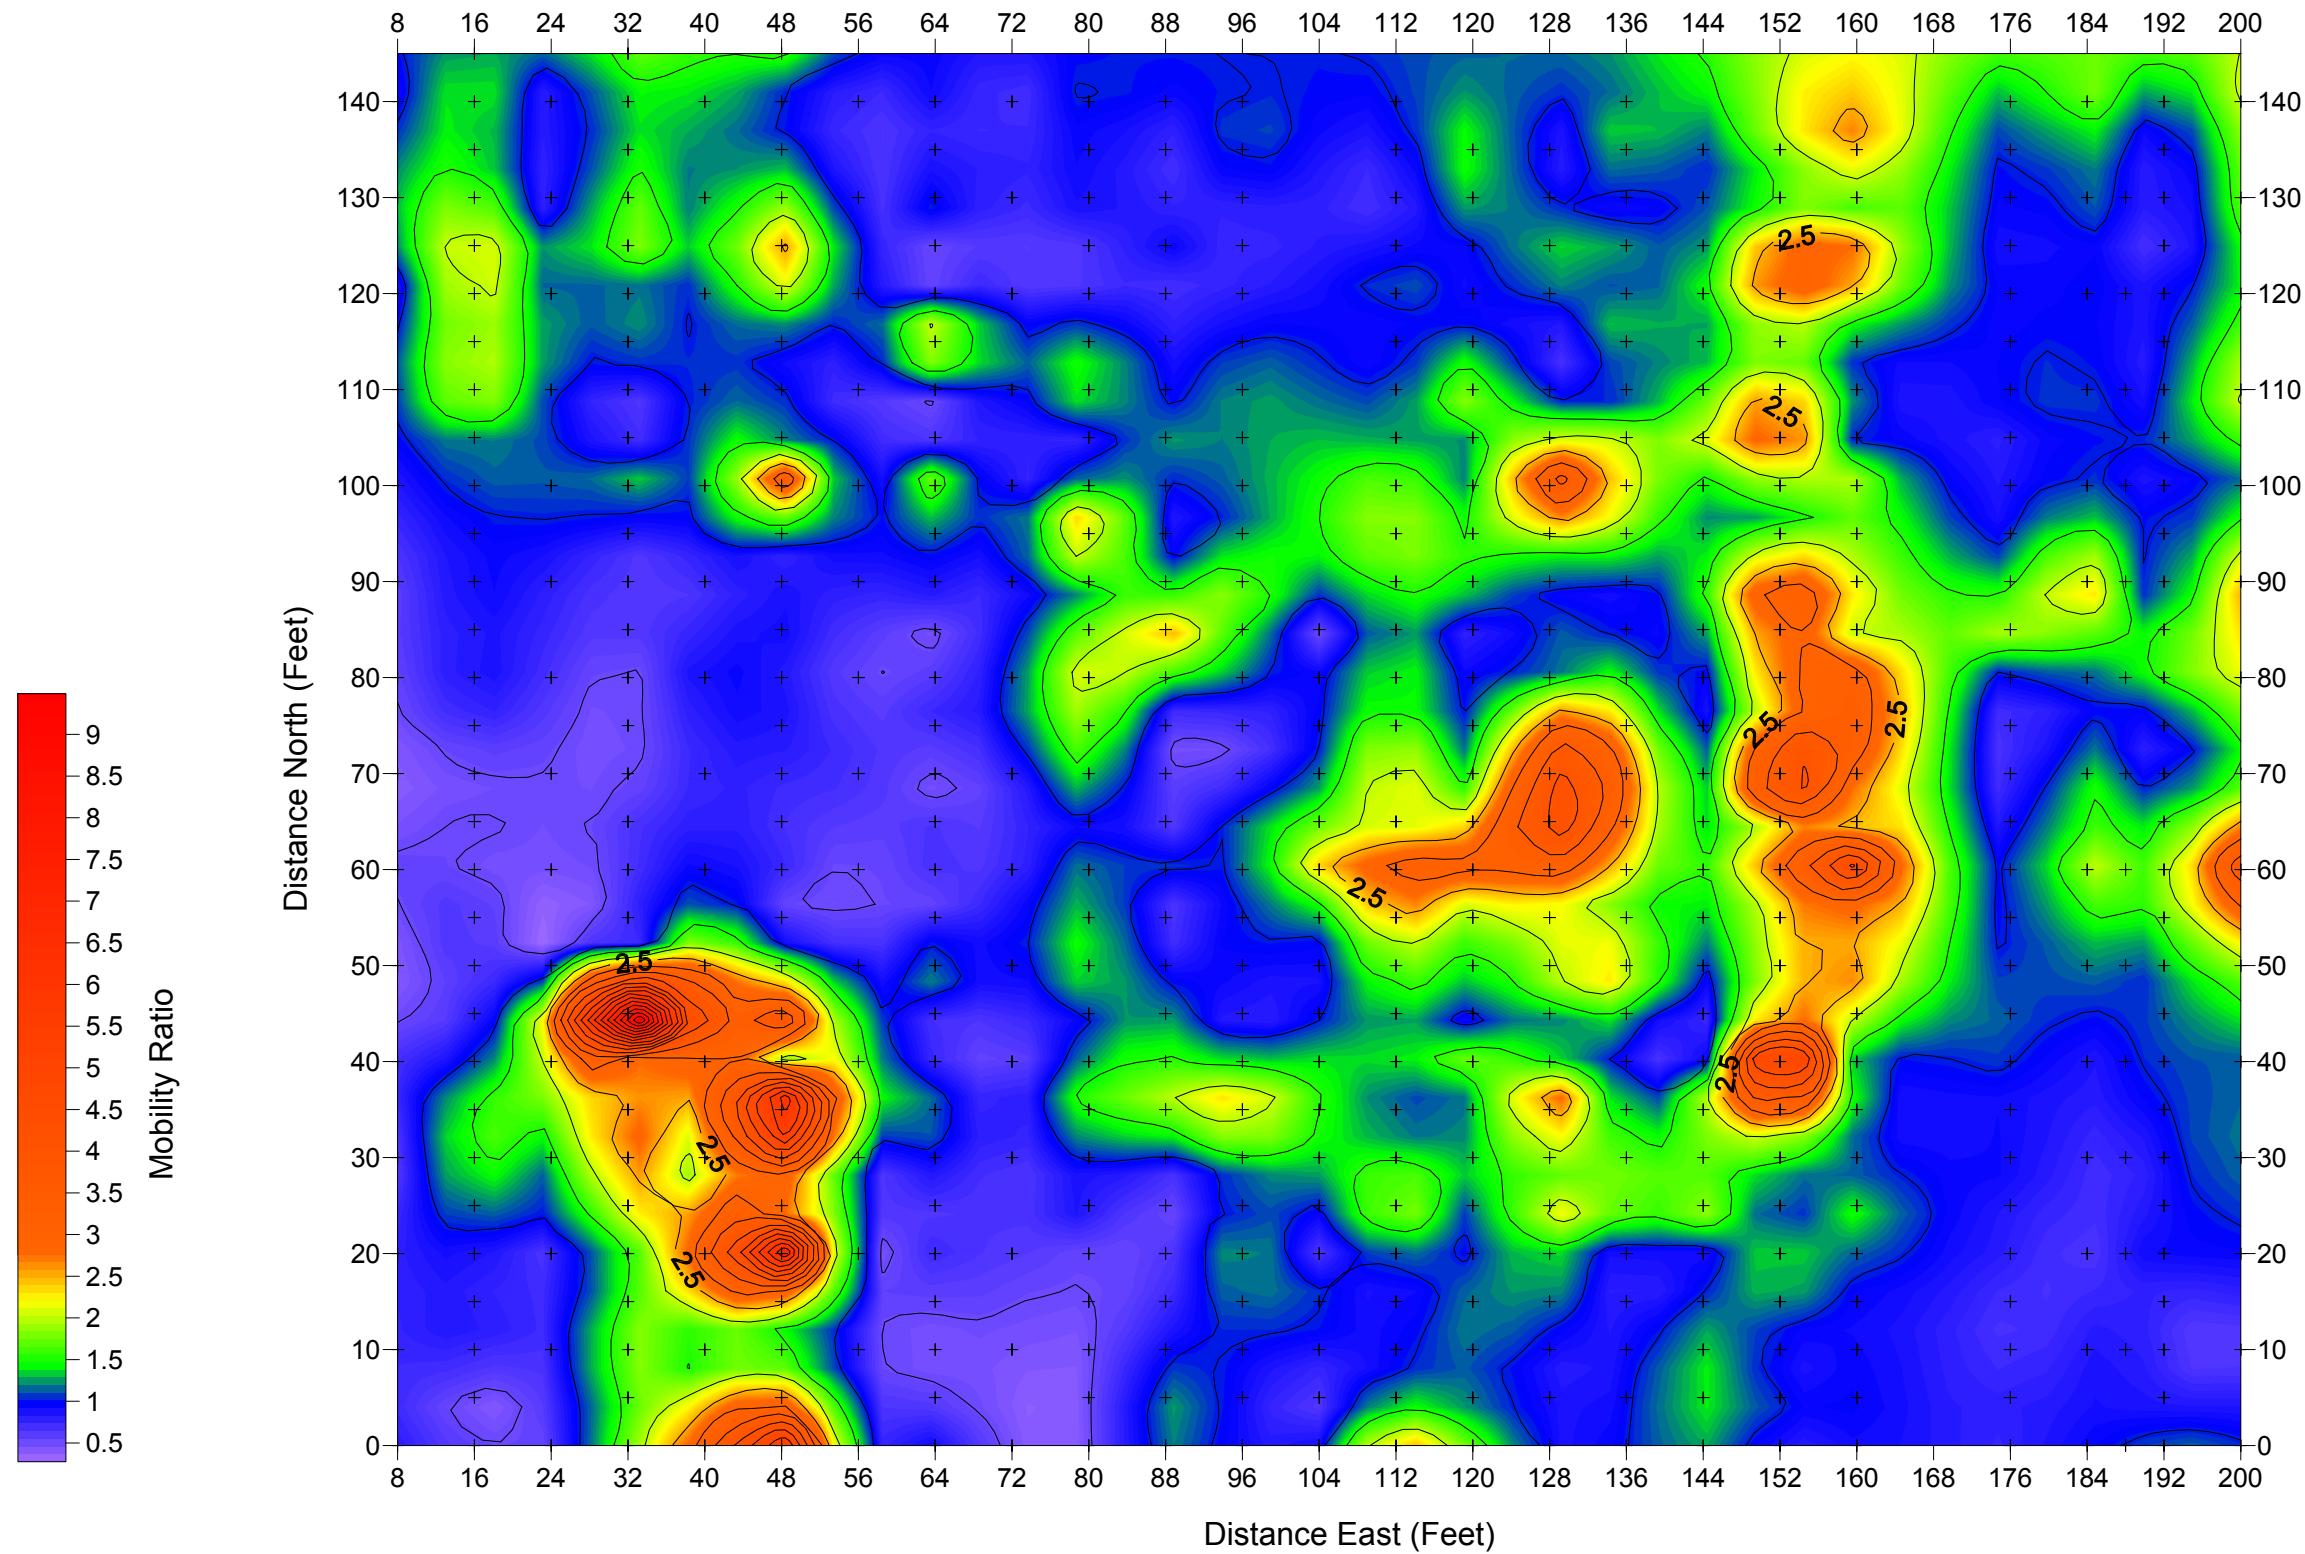
The average of the mobility spectrums for each measurement point were later evaluated in our office to identify areas where loss of pavement support or voids could exist beneath the pavement surface. Our evaluation of mobility spectrums from areas where the GPR profiles indicated void and non-void areas showed that the “mobility ratio” provided the best detection of possible void areas. The mobility ratio was calculated by dividing the peak mobility value between 0 and 100 Hertz by the average mobility between 100 and 800 Hertz. Figure 3 shows a contour mapping of this mobility ratio for the SIR measurement points positioned across the ramp area. In accordance with ASTM C1740, the areas showing a mobility ratio exceeding 2.5 indicate a likely loss of pavement support or possible void conditions. However, it is noted that higher mobility values in this frequency range could be caused by other factors such as internal defects within the concrete slab, changes in slab thickness, and nearness of joints. Therefore, the interpretation of these conditions based on SIR results alone is usually confirmed by other testing procedures such as GPR.

The slab impulse response (SIR) measurements underwent computer processing and were compared to this mapping of GPR reflections. Plate 1 displays an overlay of the areas where the SIR mobility ratio was greater than 2.5 indicating possible loss of pavement support or voids. These areas were drawn based on the contour map of mobility ratio values in Figure 3. This mobility evaluation supports our interpretation of measurable void spaces beneath the fire main break area and other areas such as the north edge of the 8-inch concrete slab which is uplifted between grid lines 20 N and 50 N. In addition, the larger pattern of mobility ratios exceeding 1.5 on the contour map in Figure 3 also compares with the distribution of void-like GPR reflection patterns across the ramp area shown in Plate 1.

Contour Map of Mobility Ratio From
Slab Impulse Response Measurements Across North Ramp Area
Hanger 4802 NASA AFRC

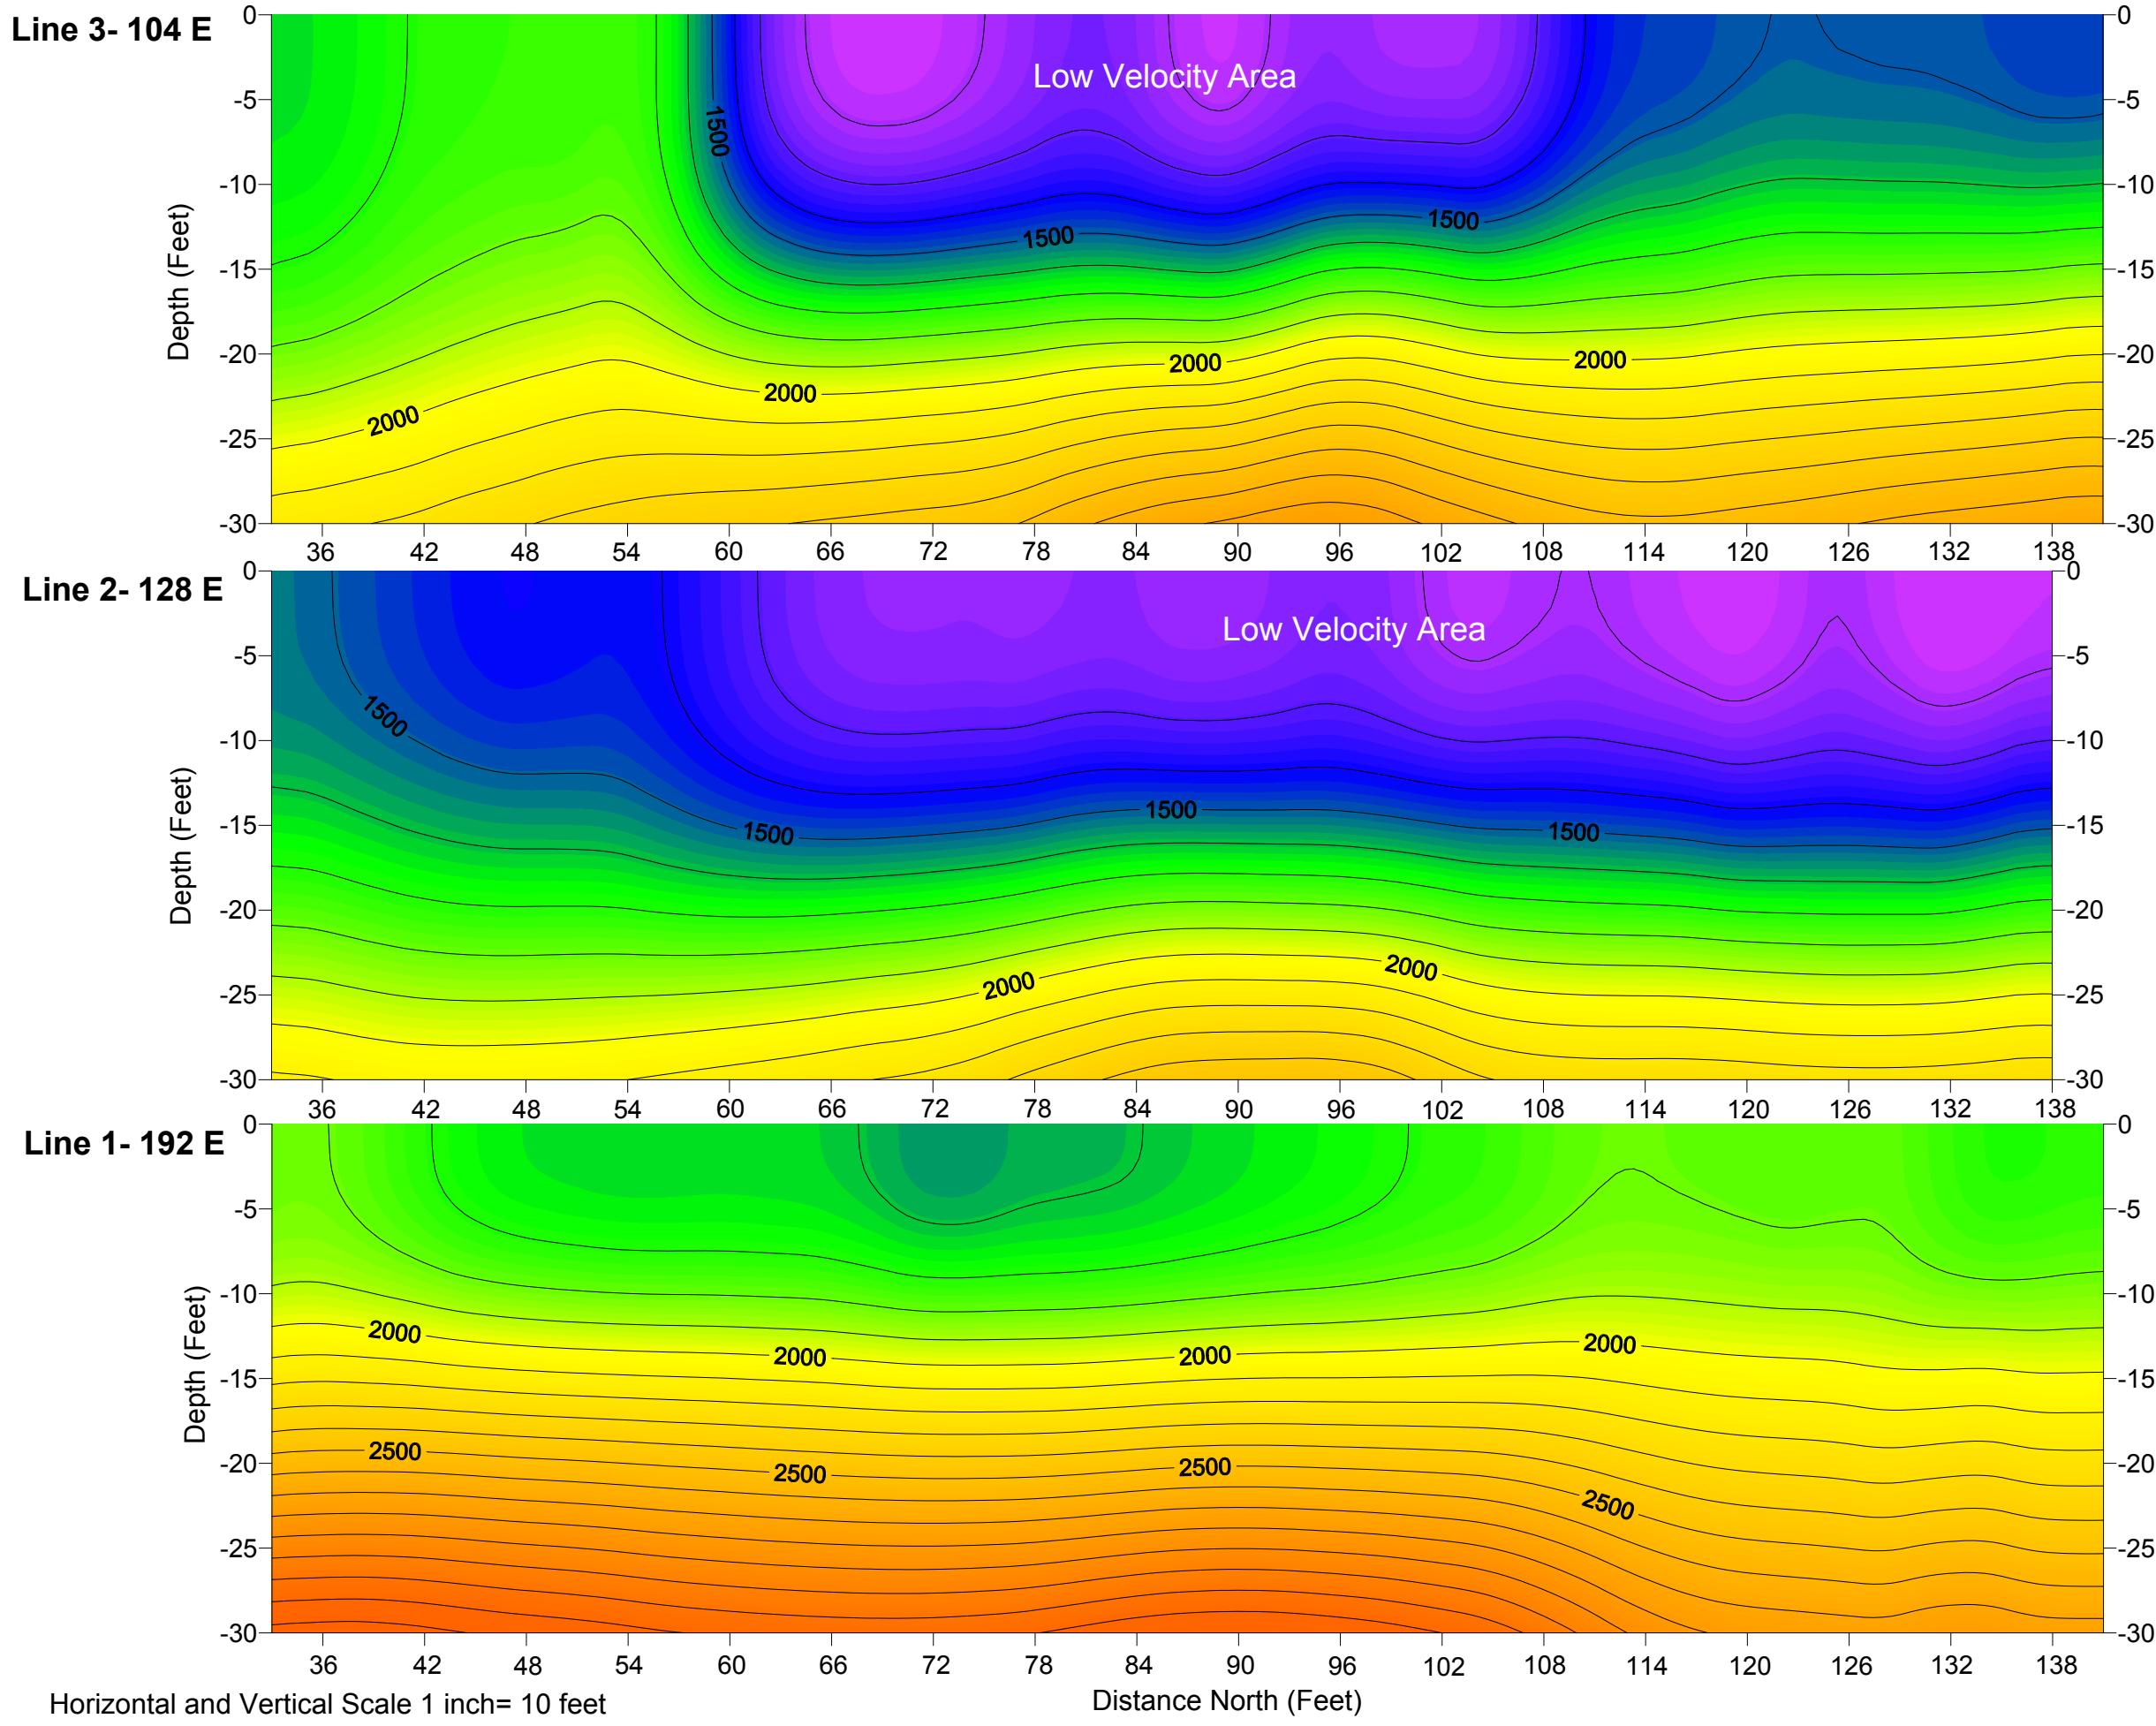
Figure 4
Advanced Geoscience, Inc.

The seismic shear-wave velocity profiling along Lines 1 through 5 (located on Plate 1) provides some initial subsurface data on the conditions of sub-grade soils beneath the pavement. These profiles are displayed in Figures 4 and 5 and reveal lower shear-wave velocity areas that appear to be caused by the wash out. The velocity profiles for Lines 2, 3, and 4 show lower velocity areas extending to north of the fire main as indicated in Plate 1. These lower velocity areas appear to be consistent with the direction of soil wash

It is also noted that Lines 2 and 3 positioned across the fire main break area show thicker lower velocity layers immediately north of the pipeline. These thicker lower velocity layers and the deeper GPR reflection patterns in this area indicate the possibility of deeper voids positioned north of the pipeline break point.

Based on these results we believe there is a thickness of voids beneath the north ramp pavement that can be measured in units of feet that extend outward from the pipeline's main break point to where they are too thin to measure. The shear-wave velocity profiles along Lines 2 and 3 also indicate there could be significant reduction in pavement support strength in the underlying sub-grade soils caused by the wash out. There could also be the possibility of deeper voids or low density conditions.

Seismic Shear-Wave Velocity Profiles
Lines 1-3 Across North Ramp Area
Hanger 4802 NASA AFRC

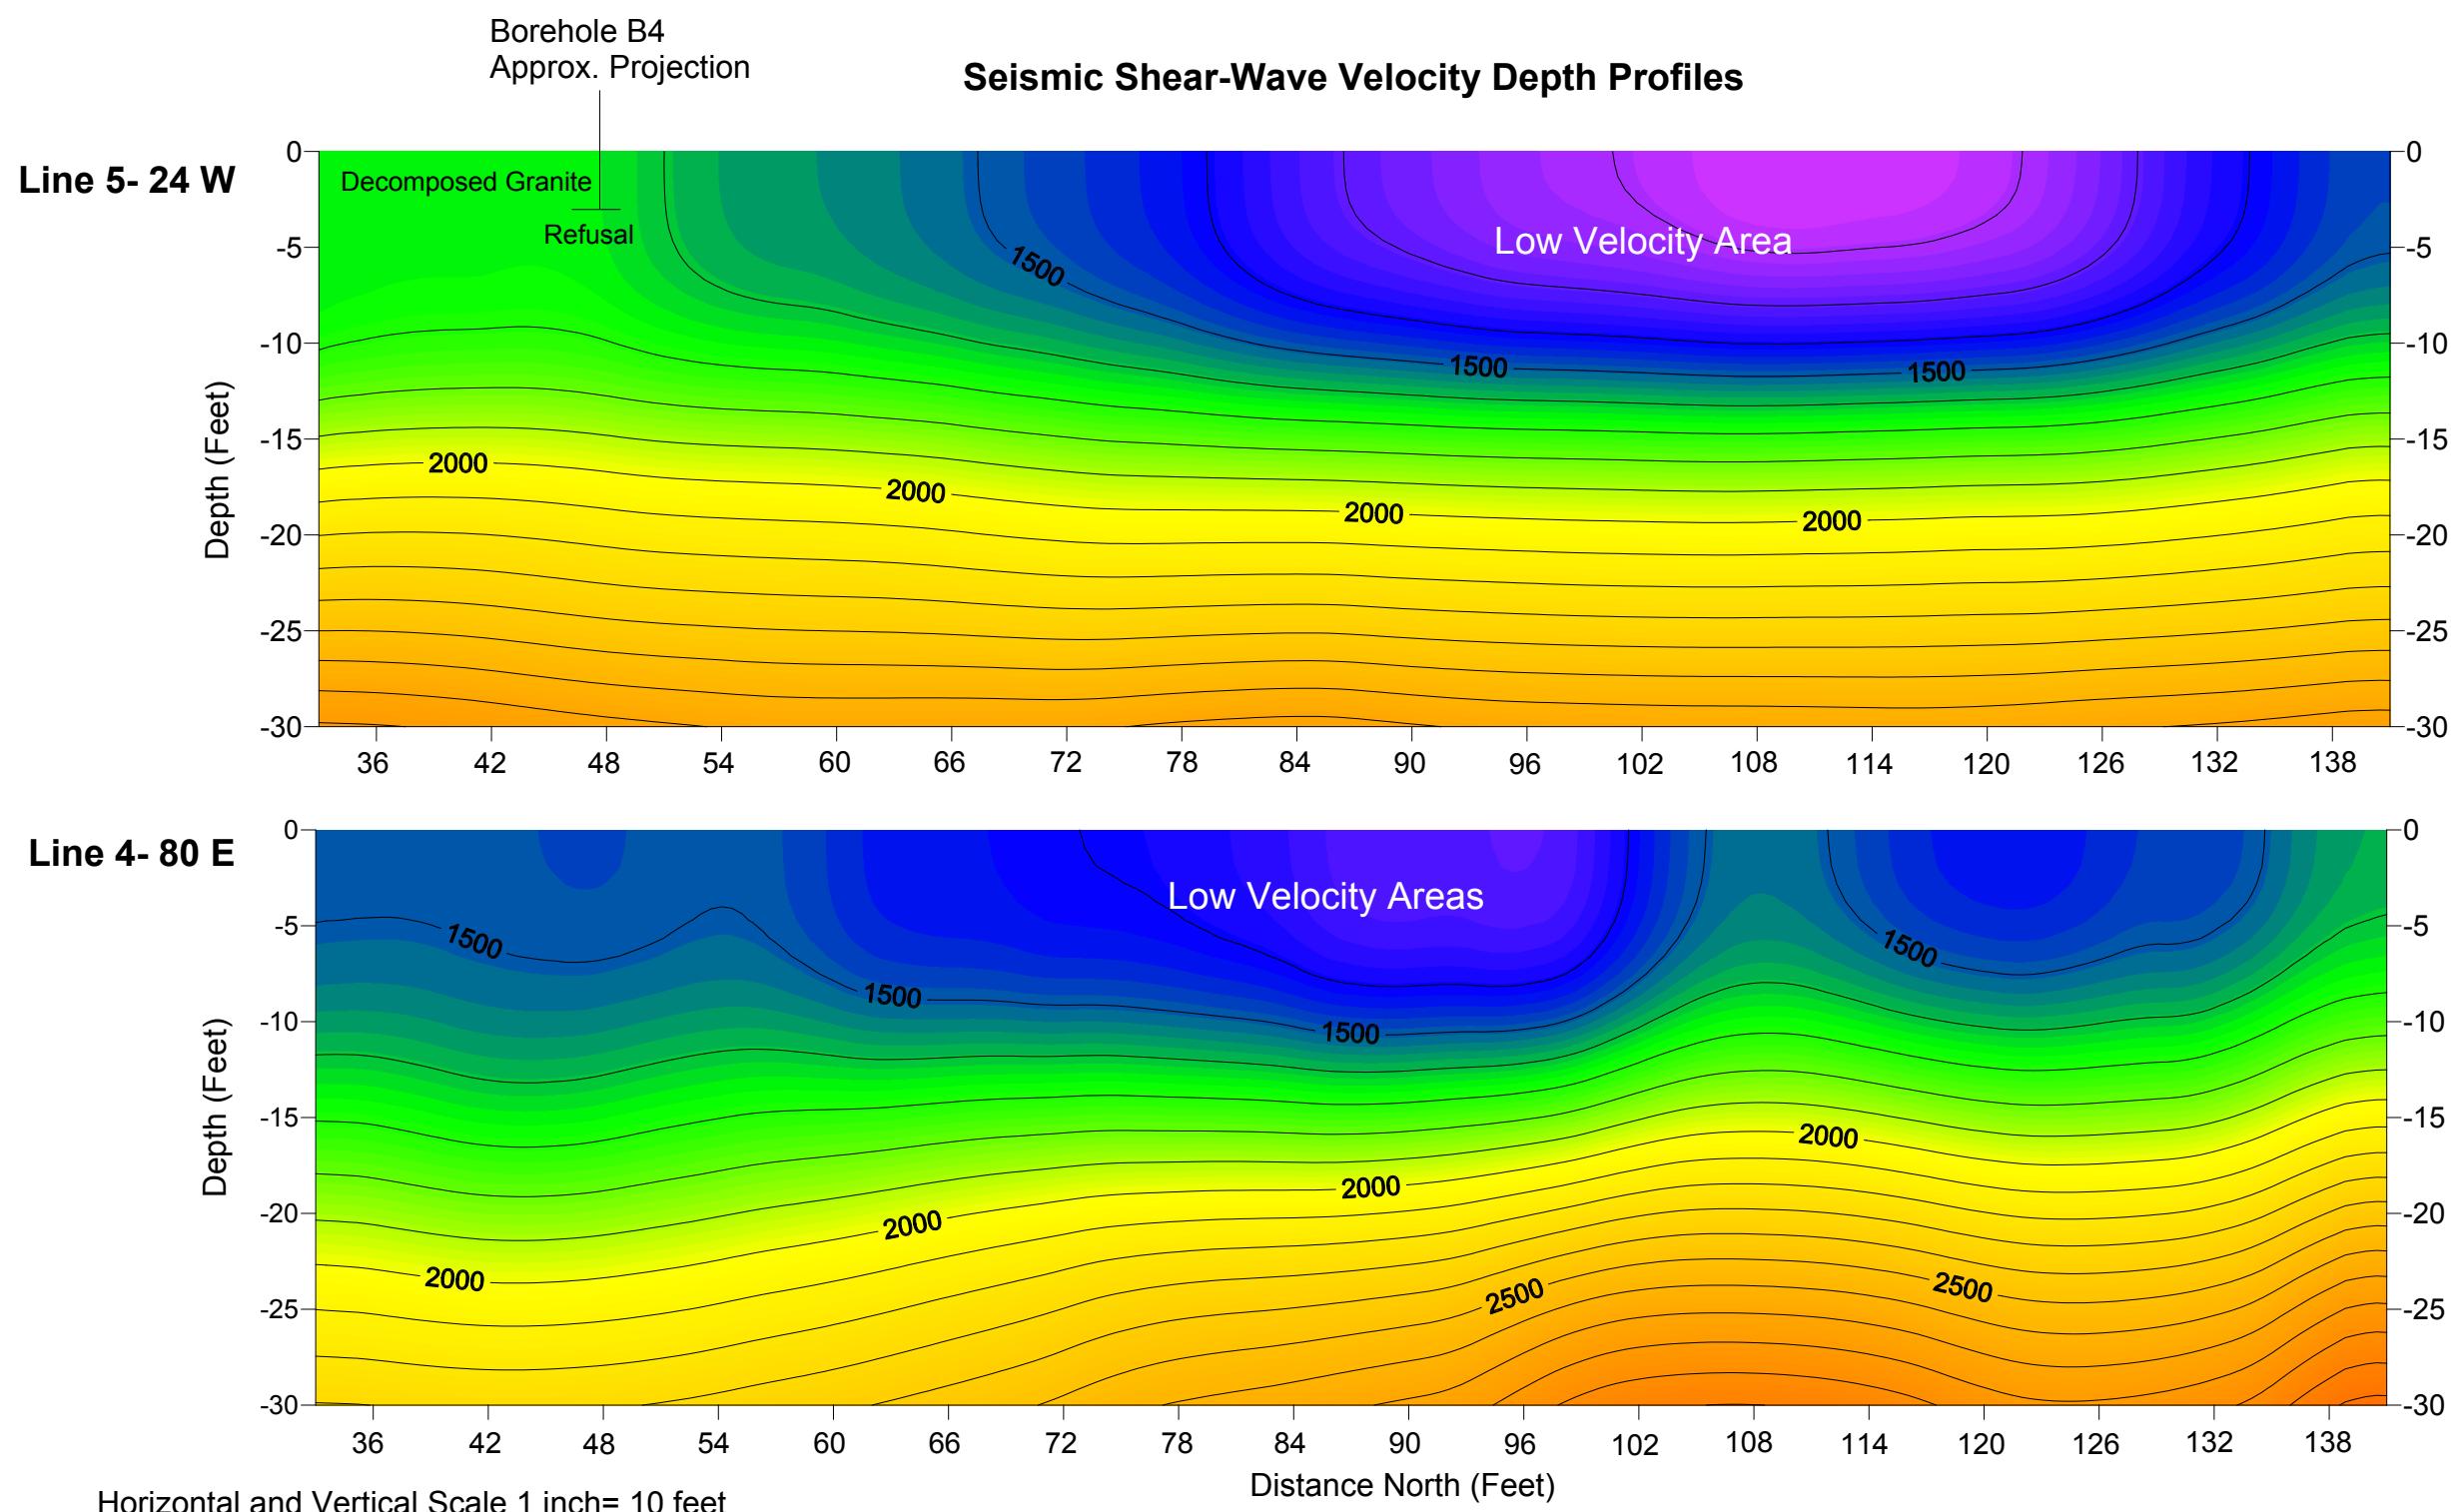
Figure 5
Advanced Geoscience, Inc.

The shear-wave velocity profile for Line 5 also shows a lower velocity area to the northwest which may or may not be caused by the wash out. This velocity profile in Figure 5 also displays subsurface geologic conditions from the lower part of the boring log obtained from nearby borehole B4 (on NASA drawings LDZ-2135). This log shows below the existing elevation of the concrete pavement a three-foot layer of granular, decomposed granite overlying a harder granite layer which had sampling refusal. This harder granite layer is interpreted as the upper surface of the weathered granite bedrock in this area. It is also noted that the other surrounding boreholes B2 and B5 in this area also reveal a 2 to 10-foot layer of unconsolidated, decomposed granite overlying harder weathered granite in this area. These subsurface geologic conditions and the variations in the 2,000 feet/sec shear-wave velocity surface on Lines 1-5 suggest there are topographic undulations in the shallow, impermeable bedrock surface that caused the more lateral movement of the water released from the fire main break.

Seismic Shear-Wave Velocity Profiles
Lines 4-5 Across North Ramp Area
Hanger 4802 NASA AFRC

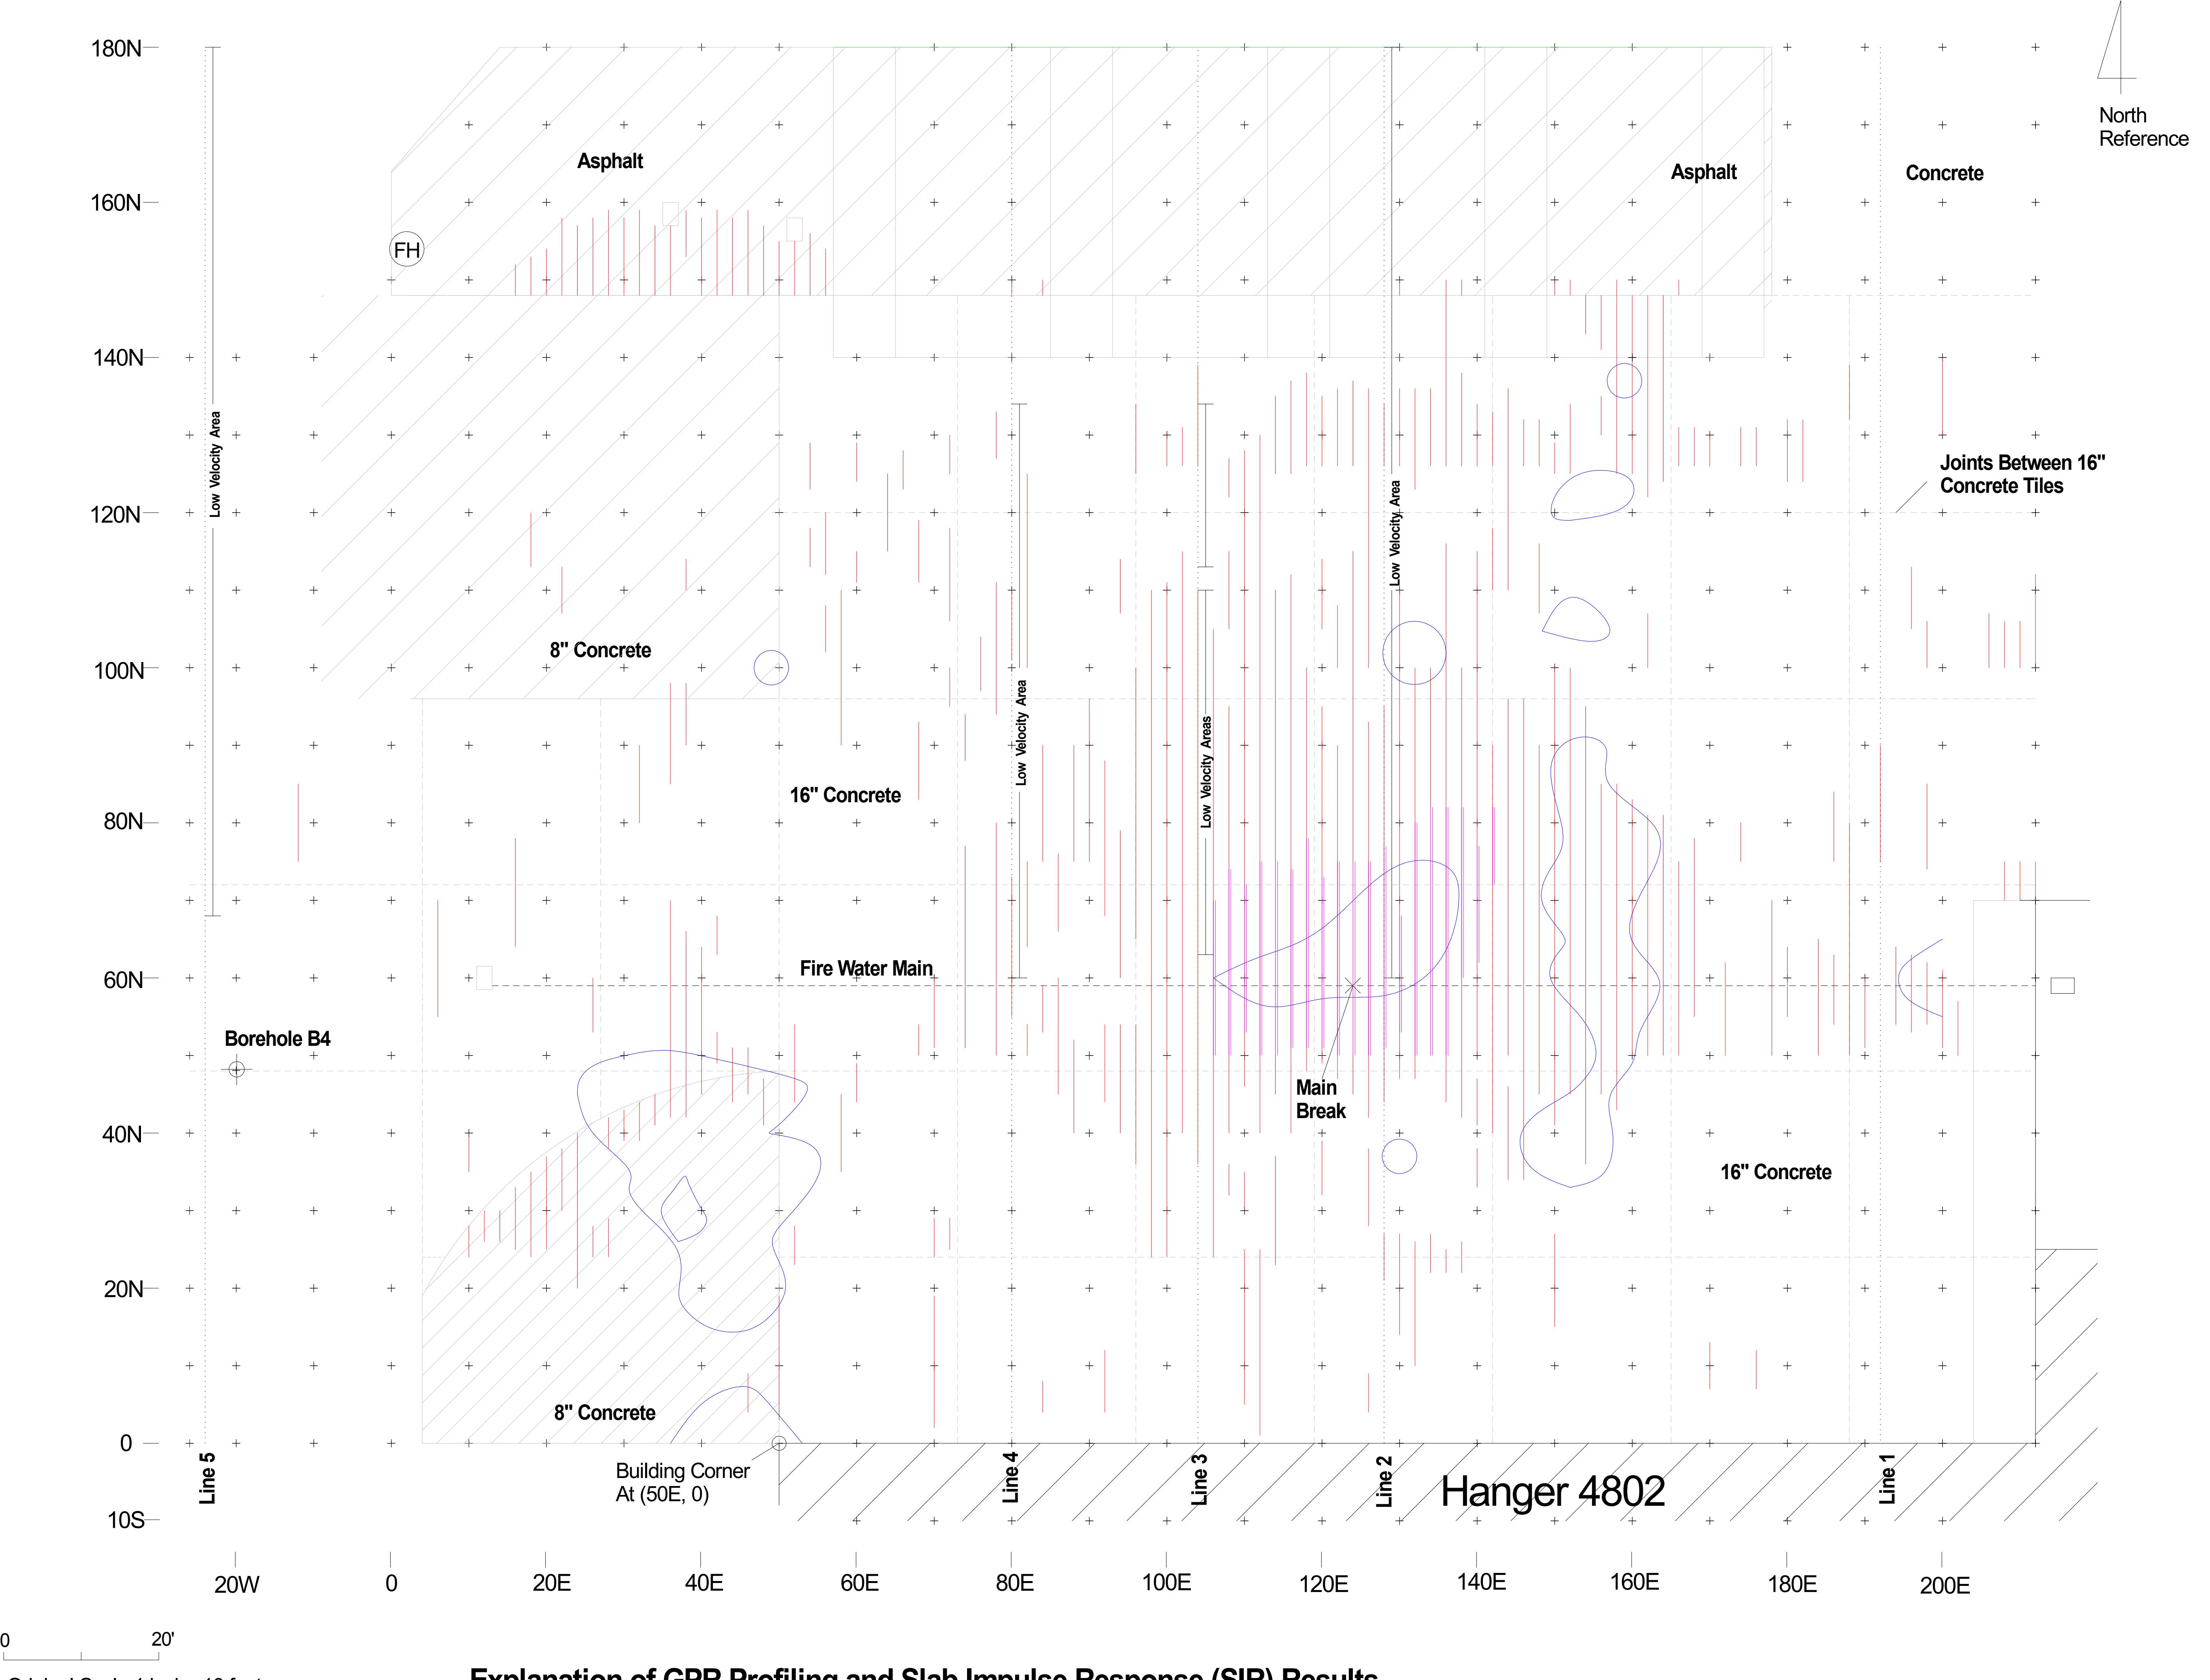
Based on this video inspection we determined the main break point was beneath grid line 124 E along the fire main as shown on Plate 1.

GPR Reflections Indicate Voids Beneath Pavement

GPR Reflections Indicate Thicker Voids Beneath Pavement

Areas Where SIR Mobility Ratio is Greater Than 2.5
Indicating Loss of Pavement Support or Voids Beneath Pavement

Site Grid Map Showing Results of Subsurface Investigation
North Ramp Area at Hanger 4802
NASA Armstrong Flight Research Center

Further subsurface investigation by direct methods should be performed across the ramp area. We recommend that six to eight core holes be drilled in void and non-void areas shown in Plate 1 through both concrete and asphalt pavements. These core holes should be used to collect concrete cores and soil samples for laboratory testing. Accurate measurements of void spaces should be made together with visual observations using a borehole camera on the top layer of soil. Intact soil cores should also be recovered for laboratory testing of density.

If ramp repairs are initiated without additional subsurface investigation it is recommended that the ramp's concrete tiles first be removed in the area shown on Plate 1 where the GPR profiling shows thicker void spaces surrounding the main break point. The subsurface inspection and subsequent removal of concrete tiles could then be continued in an outward direction from this area.
