Subject: Report Seismic Reflection and Refraction Surveys for Investigation of Subsurface Faulting at Sansum Properties At 215 Pesetas Lane Santa Barbara, California

Seismic Reflection Time Profile Investigation of Subsurface Faulting Sansum Medical Facility Santa Barbara, California

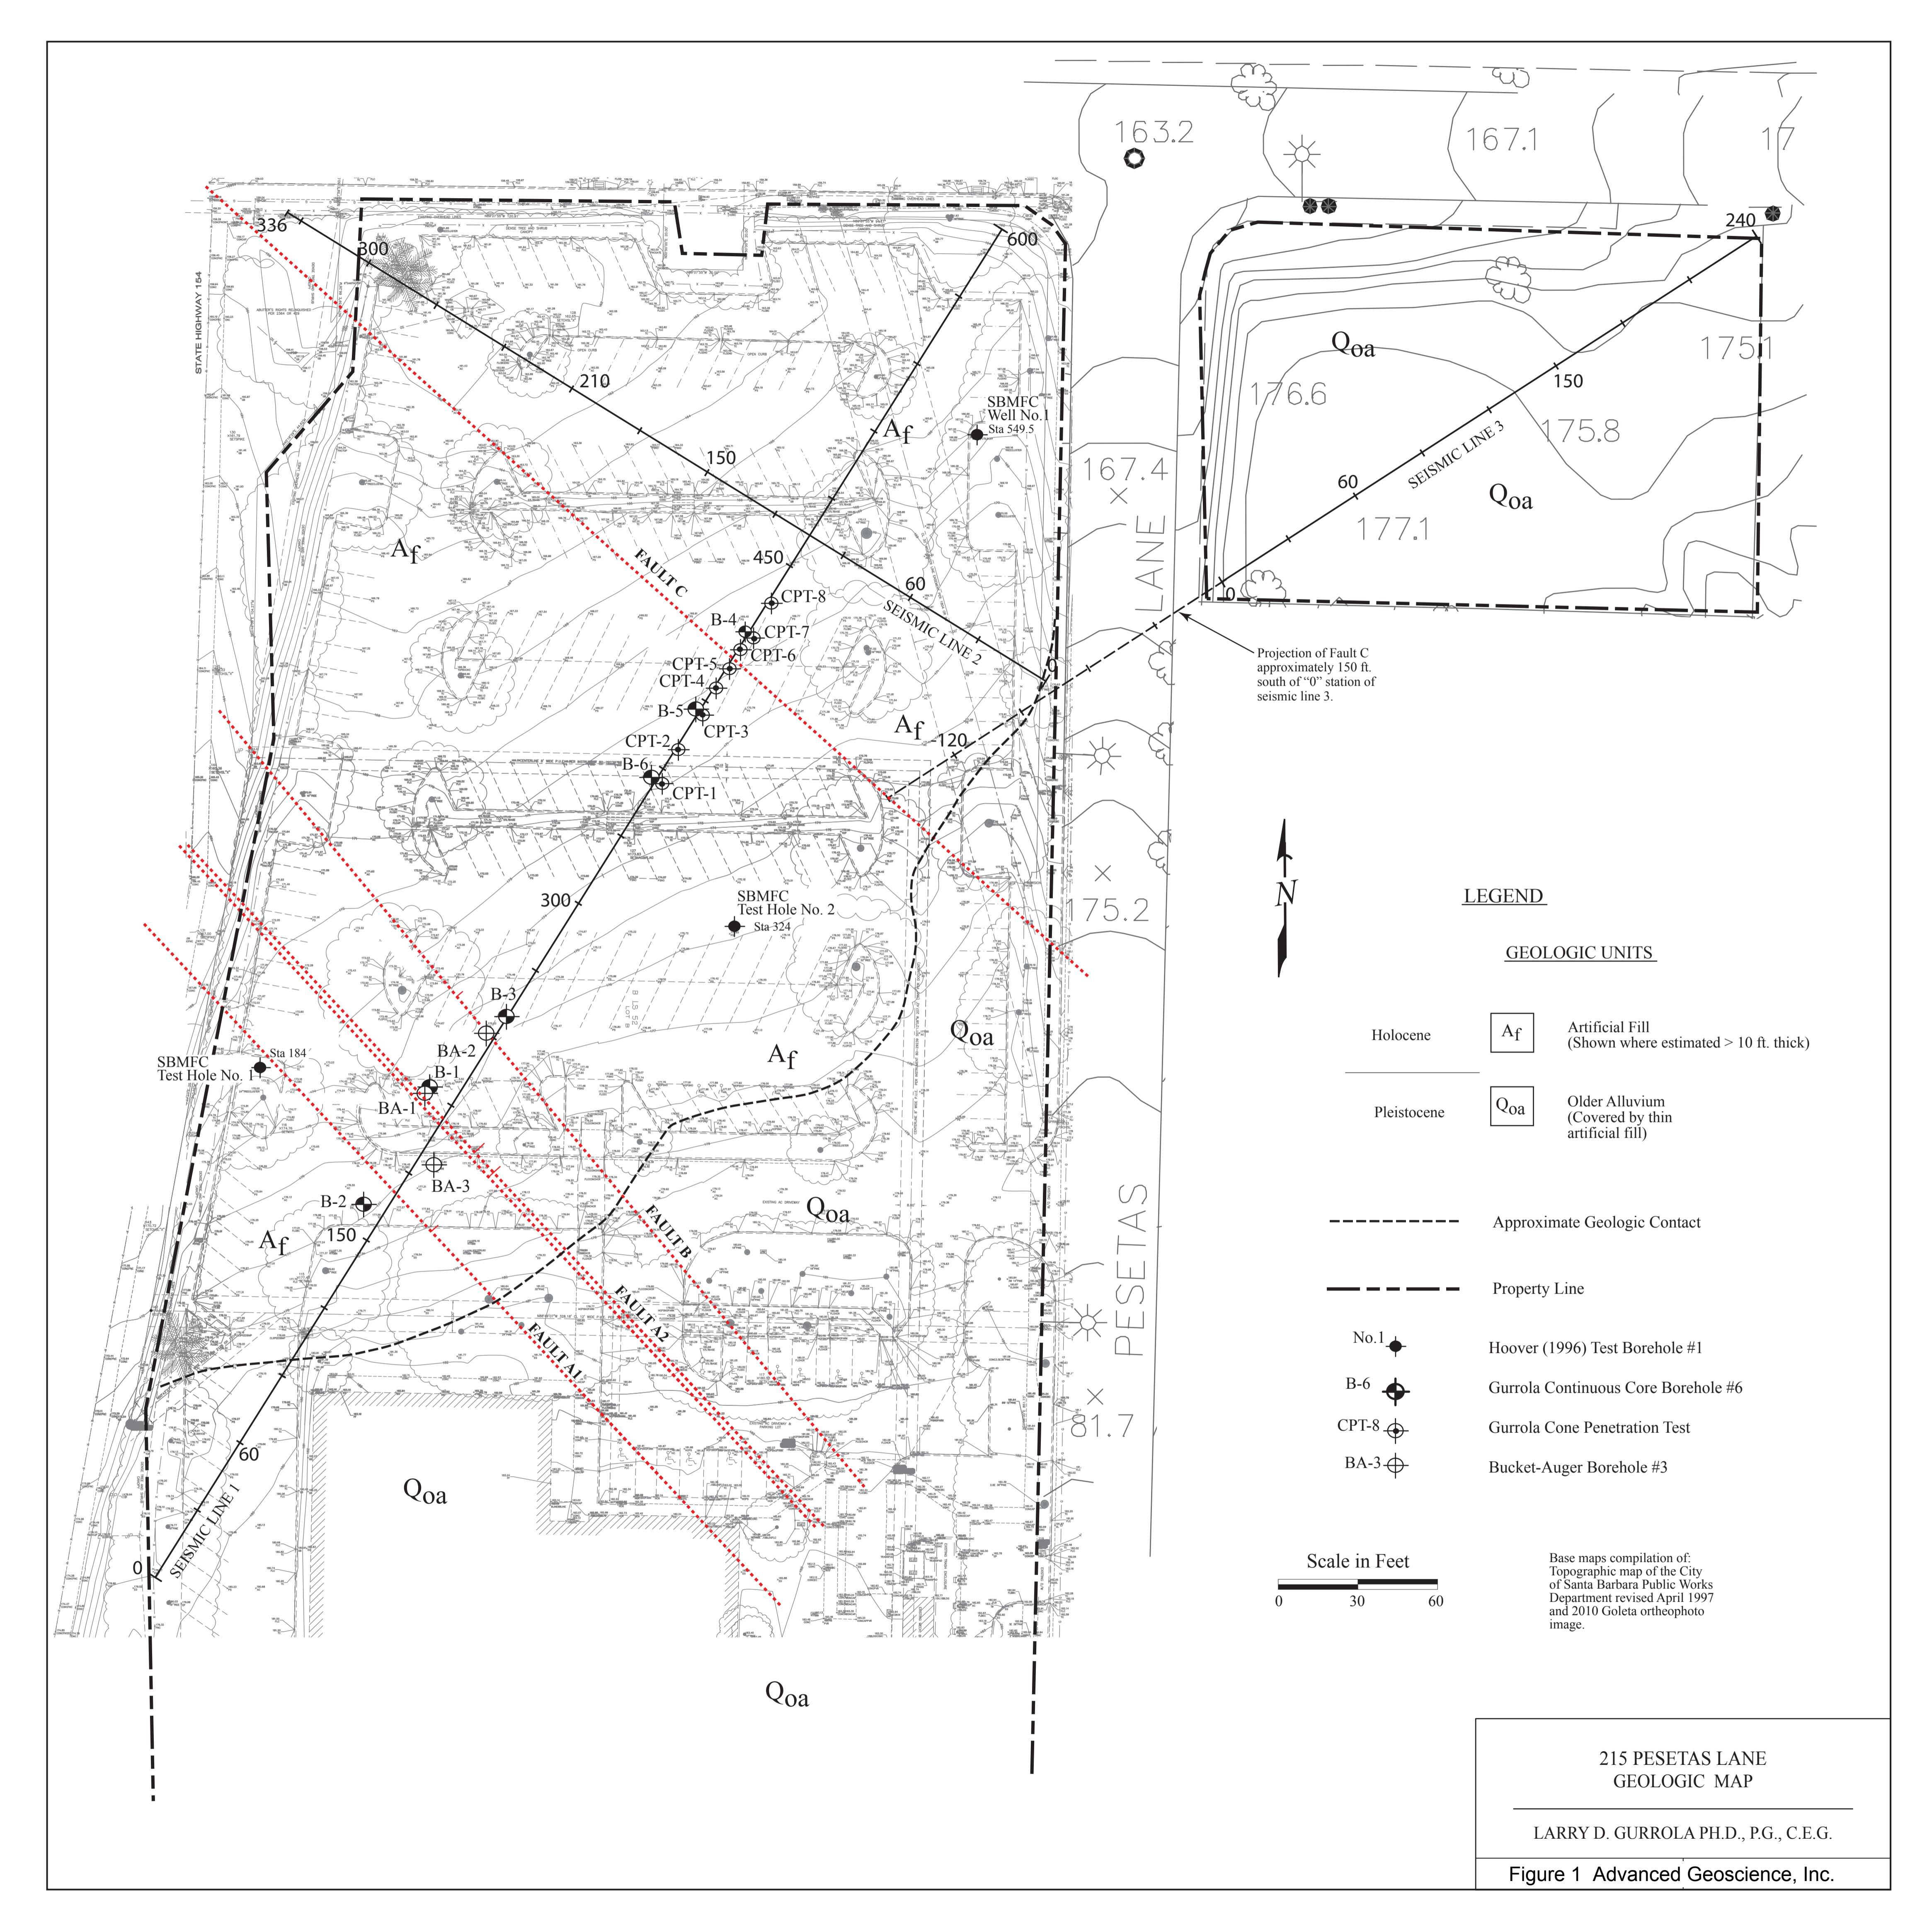
"Fault C" is also interpreted on the Line 1 reflection profile further to the north near station 410 feet. This fault plane is also dipping to the north. The reflection profiles for Lines 2 and 3 (Figures 3 and 4) show reflection patterns associated with this north-dipping fault plane where Fault C is expected to intersect these profiles. The approximate strike orientation of "Fault C" in Figure 1 is estimated by connecting the Line 1 trace with the near-surface projection trace of Line 3.

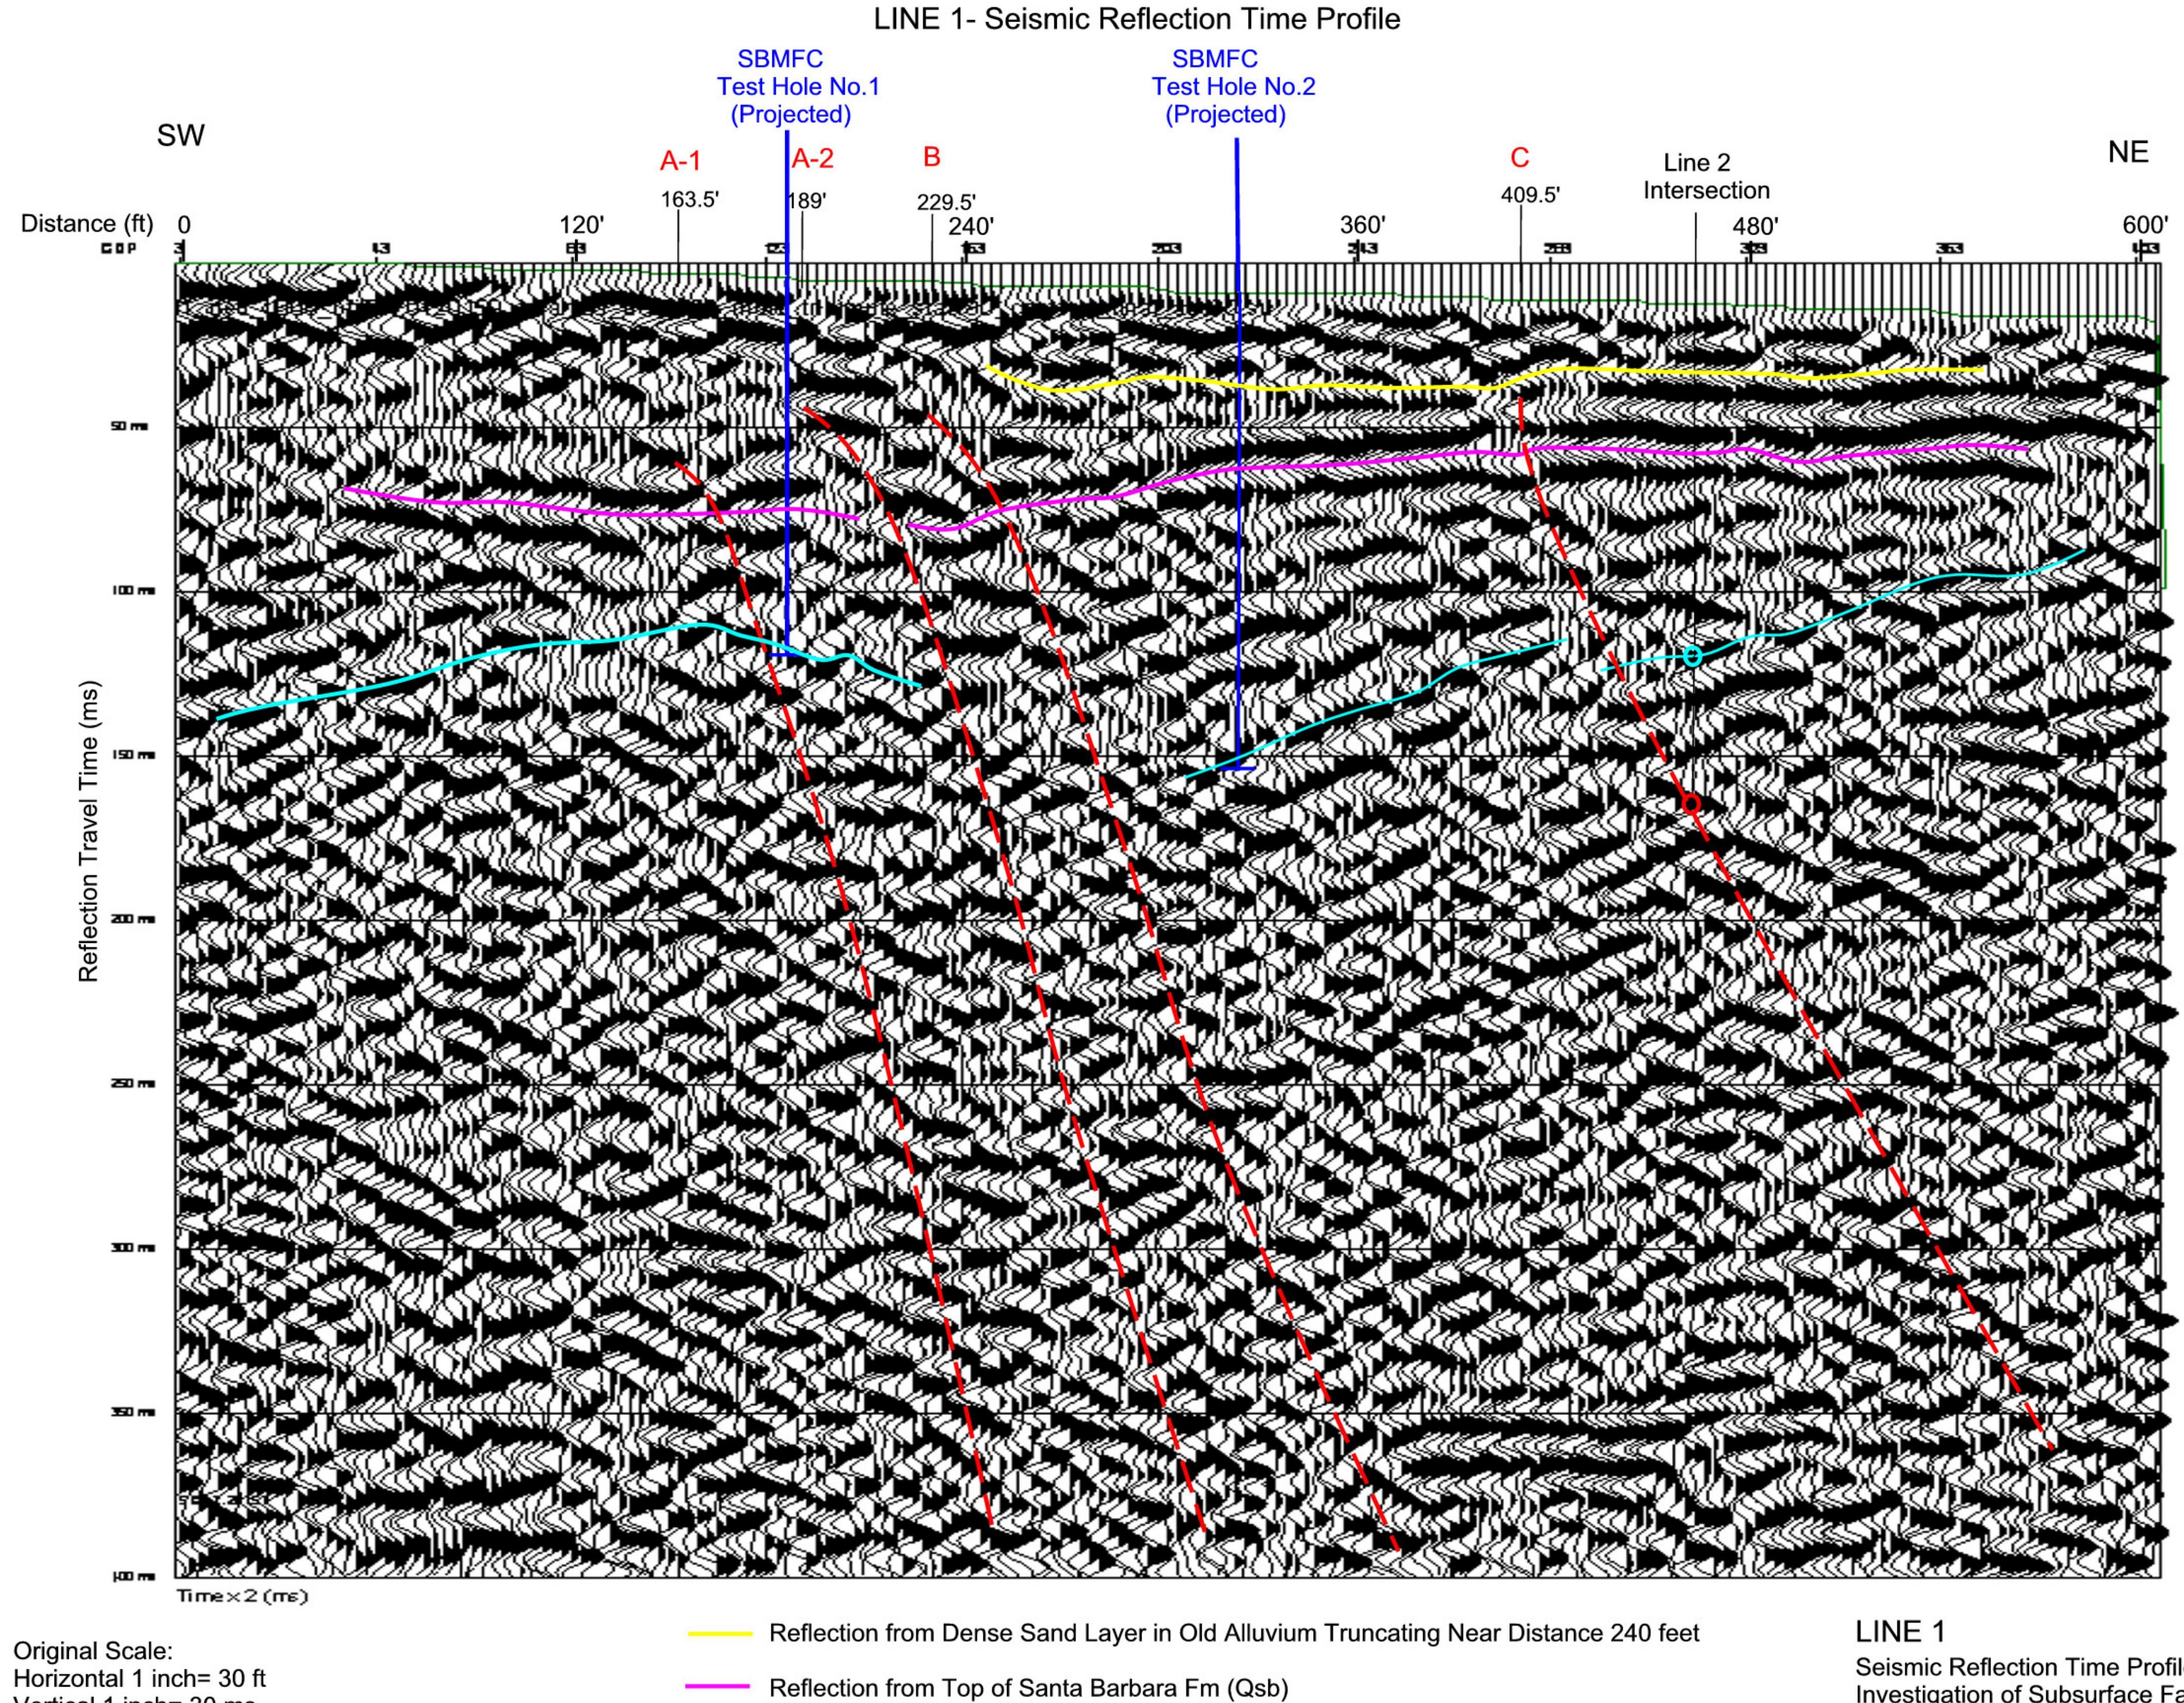
Figure 2 March, 2016

A pattern of north-dipping, subsurface faulting is interpreted on the Line 1 seismic reflection profile. This faulting is believed to be associated with the northwest-trending San Jose fault pattern mapped near this site.

The more significant north-dipping faults designated as "Faults A-1, A-2, and B" are shown on the reflection profile for Line 1 between stations 160 and 240 feet (Figure 2). The positions of faults based on this study are approximate and subsurface exploration with borings and CPT's may refine these fault locations. In the area between stations 160 and 240 feet, the magenta reflection horizon shows an abrupt change in slope and vertical separations. The seismic refraction velocity profile (Figure 5) also shows abrupt changes in slope and vertical separation of velocity layering within the old alluvium and deeper units. This interpretation of more significant faulting across this area is supported by the logs from earlier SBMFC test hole numbers 1 and 2 which showed 190 feet of vertical separation between the deeper shale layers near the top of the Miocene section.

Interpreted Fault Planes Projecting Near Surface Older Monterey Fm Fault Planes Not Shown

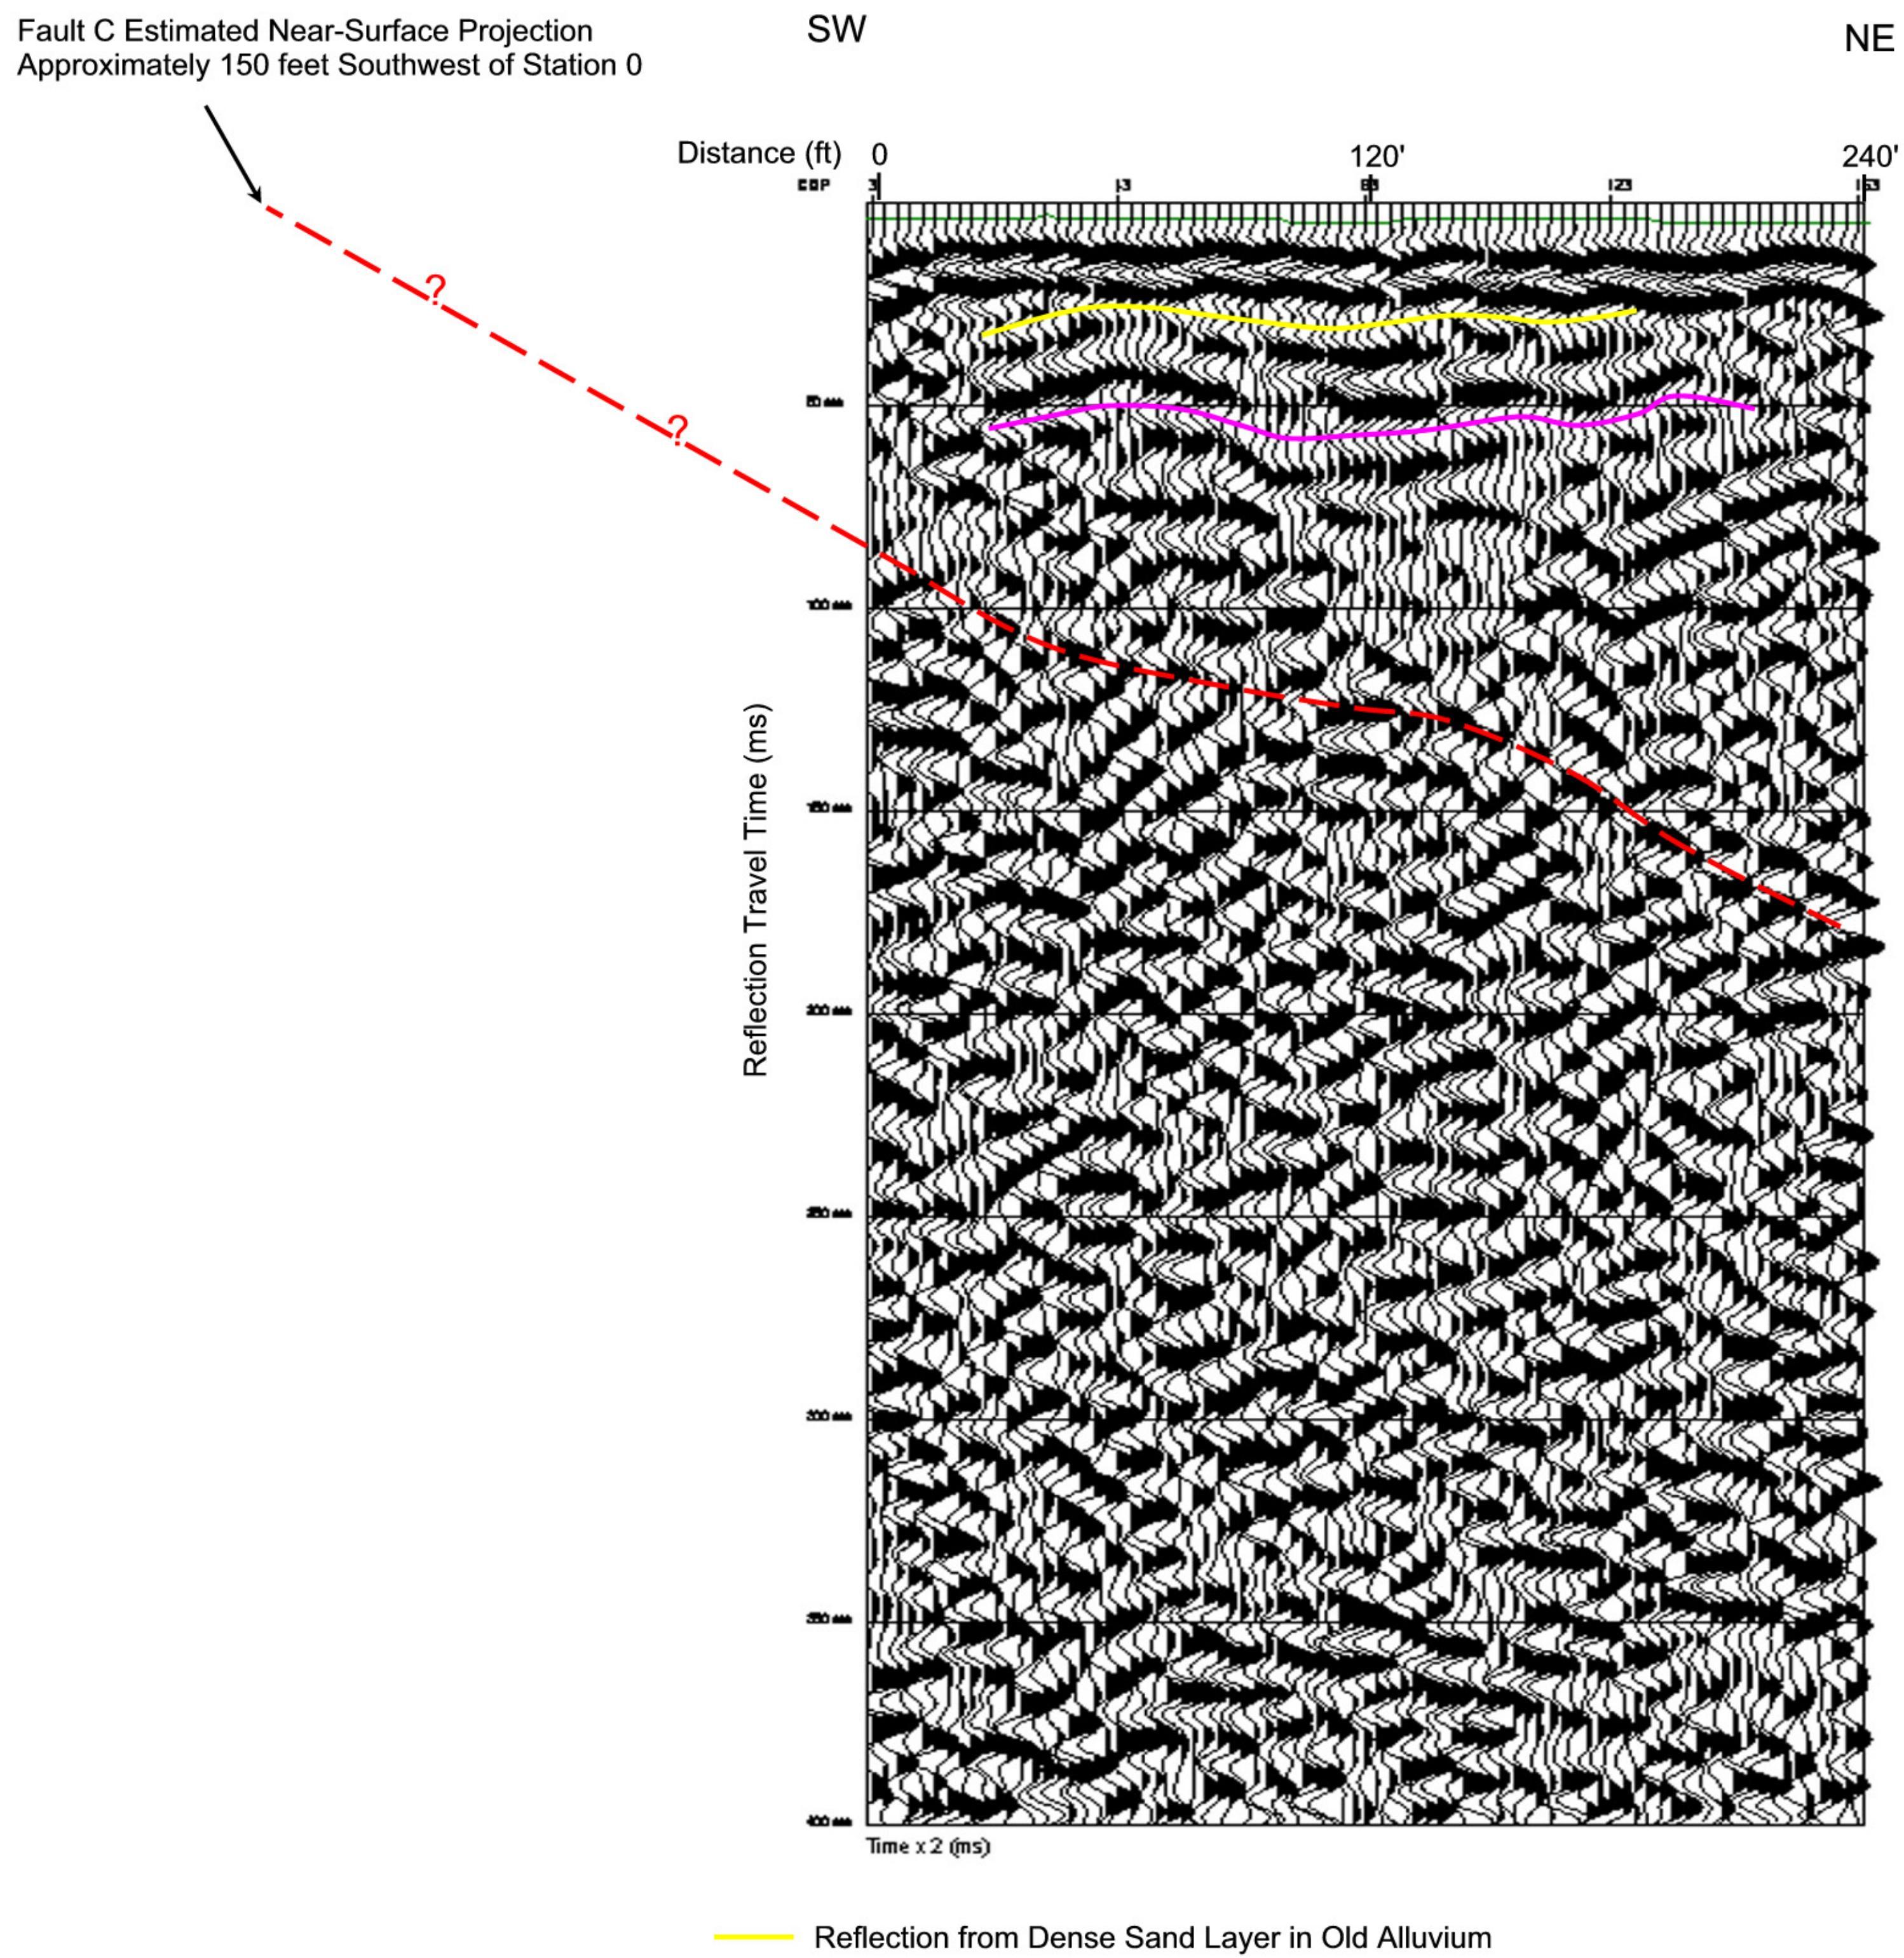
> Figure 4 March, 2016

Ranch fault. However, the seismic reflection and refraction profiles did not reveal abrupt changes in slope or vertical separations in layering which indicated this fault is not present at this site. Line 3 was positioned along a northeast transect on the corner lot to intersect a possible trend of the San Jose fault. However, the seismic reflection and refraction profiles did not reveal abrupt changes in slope or vertical separations in layering which indicated this fault is not present at this site.

Fault C Intepreted Fault Plane Orientation
Based on Pattern of Northeast Dipping Reflections

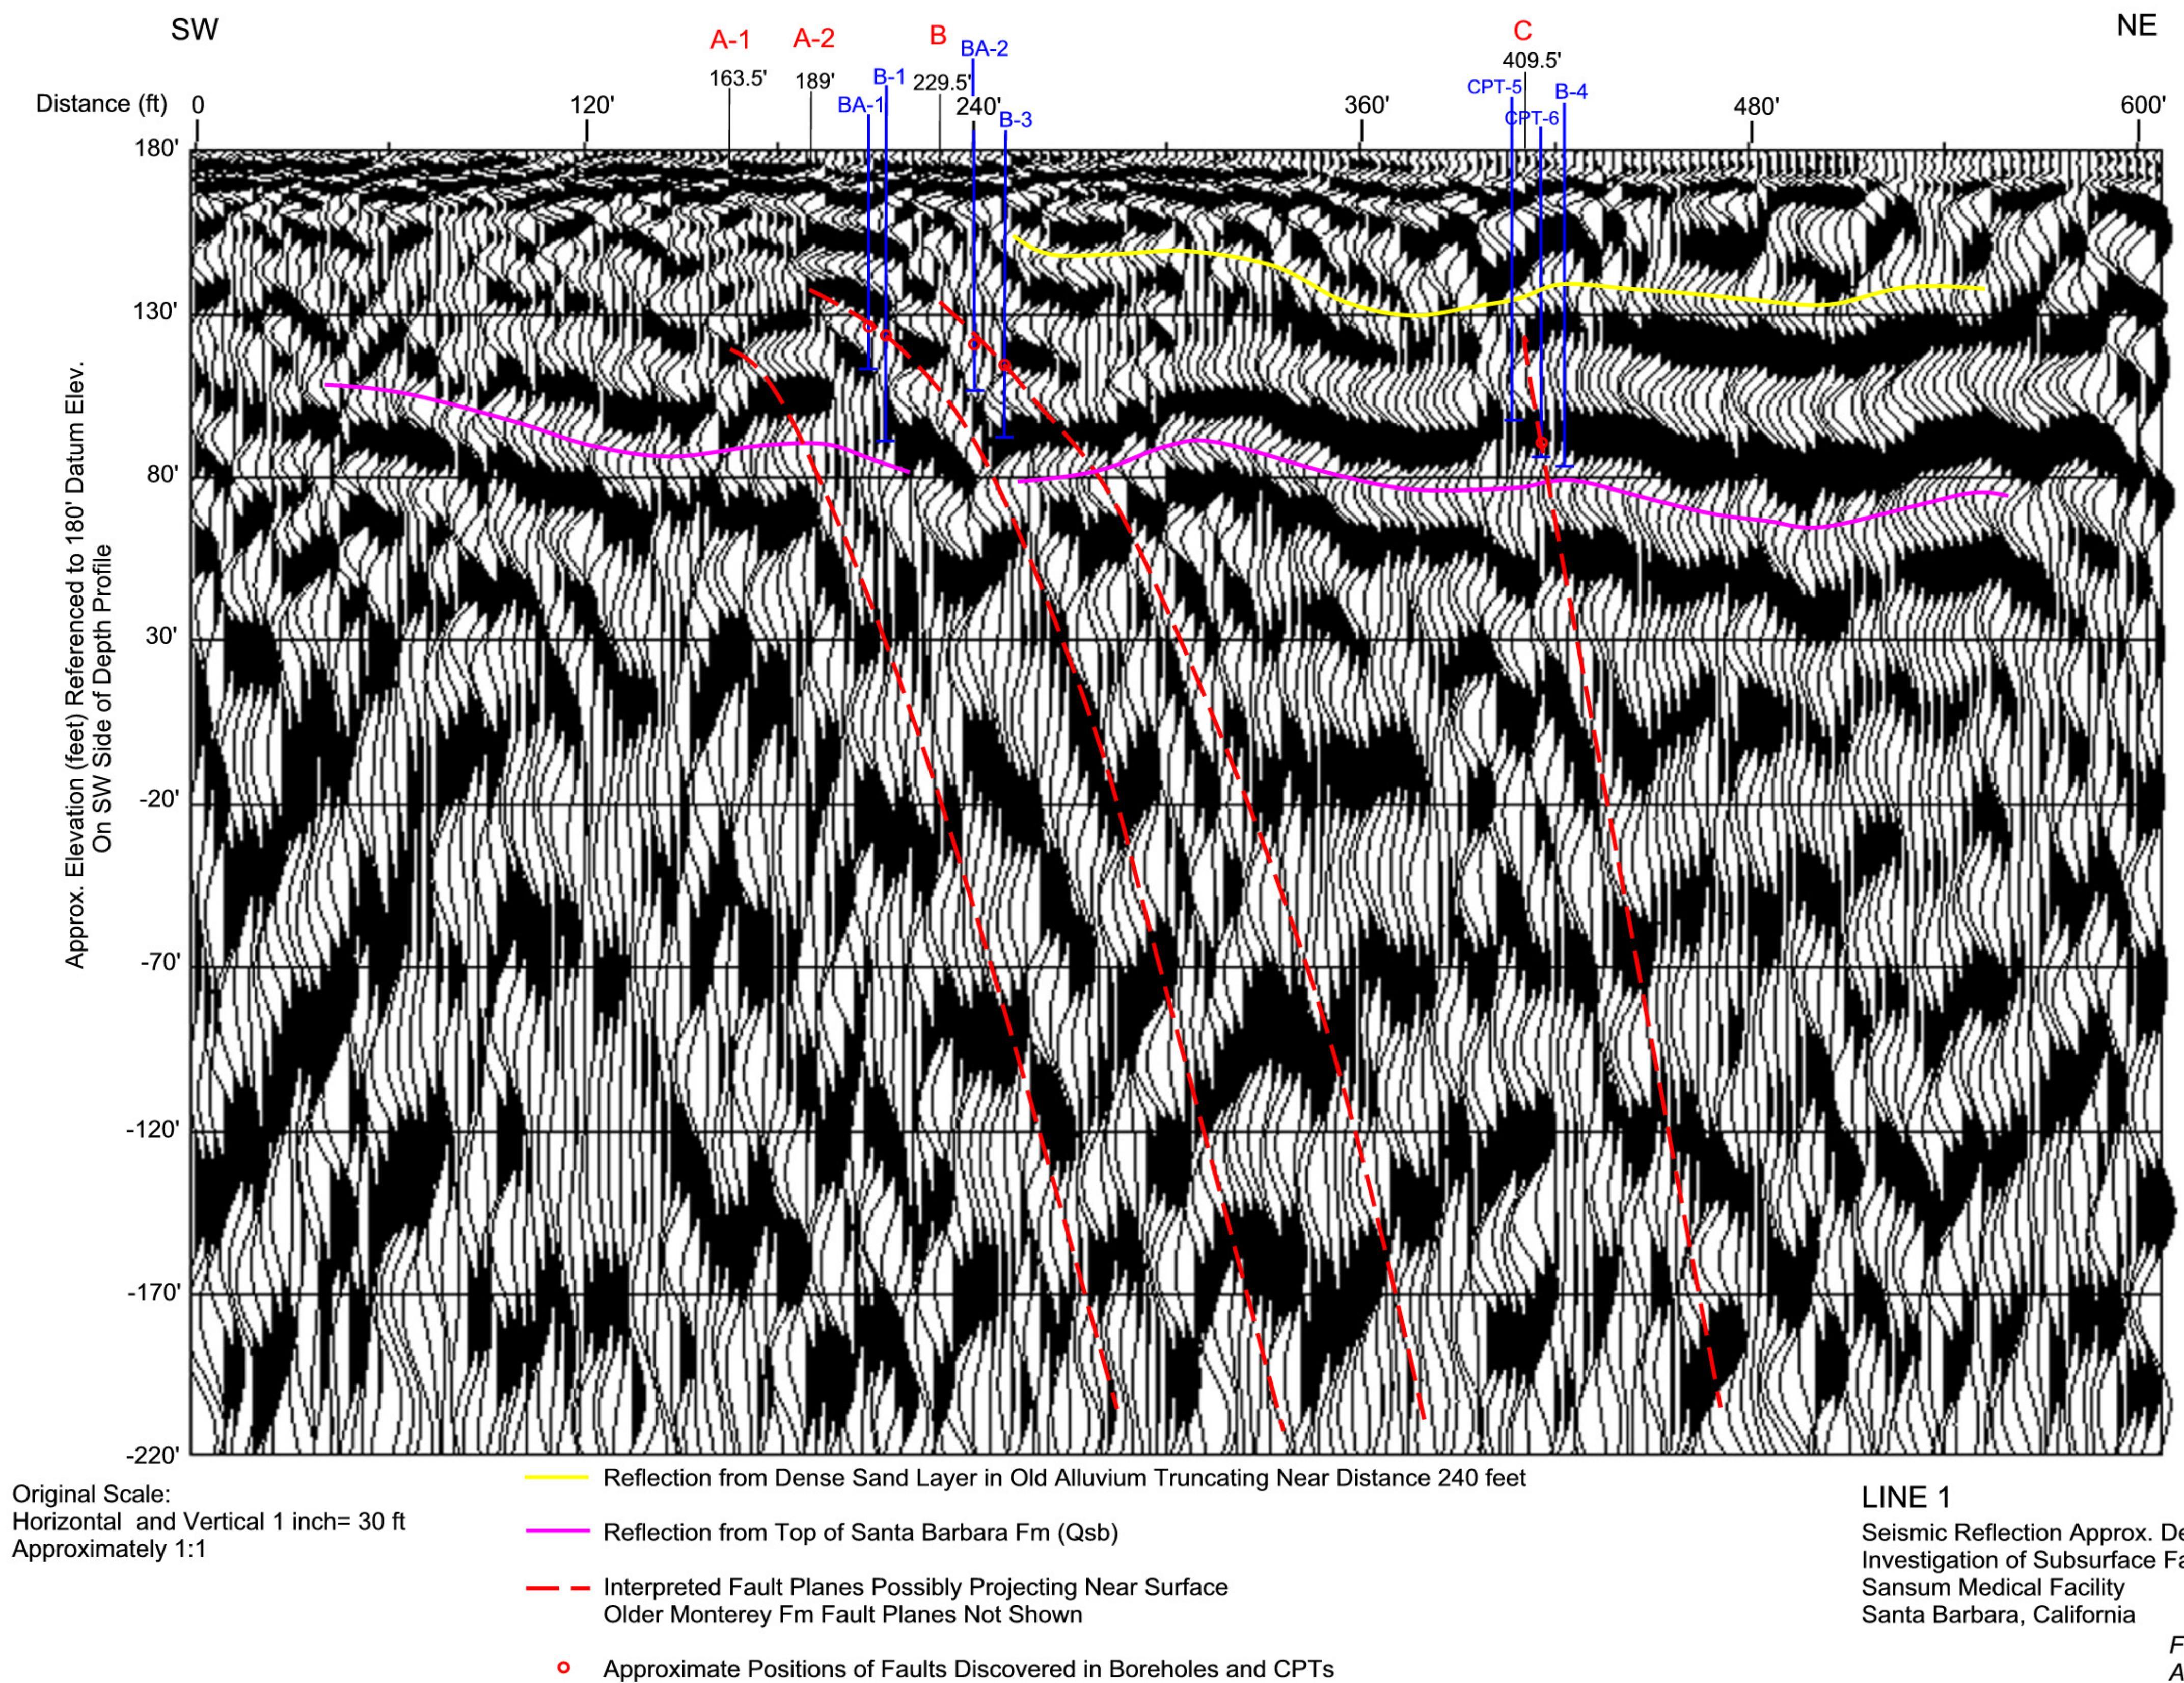
Figure 7 March, 2016

The fault plane orientations for Faults A-1, A-2, B, and C are shown on the Line 1 reflection depth profile (Figure 7) at an approximate 1:1 horizontal and vertical scale. The final interpretation of these fault plane orientations near the surface is shown to be consistent with the positioning of faulting interpreted on the geologic cross section prepared from the boreholes and CPTs.
