Subject: Report Seismic Reflection and Refraction Surveys for Investigation of Subsurface Faulting at Sansum Properties At 215 Pesetas Lane Santa Barbara, California

Seismic Reflection Time Profile Investigation of Subsurface Faulting Sansum Medical Facility Santa Barbara, California

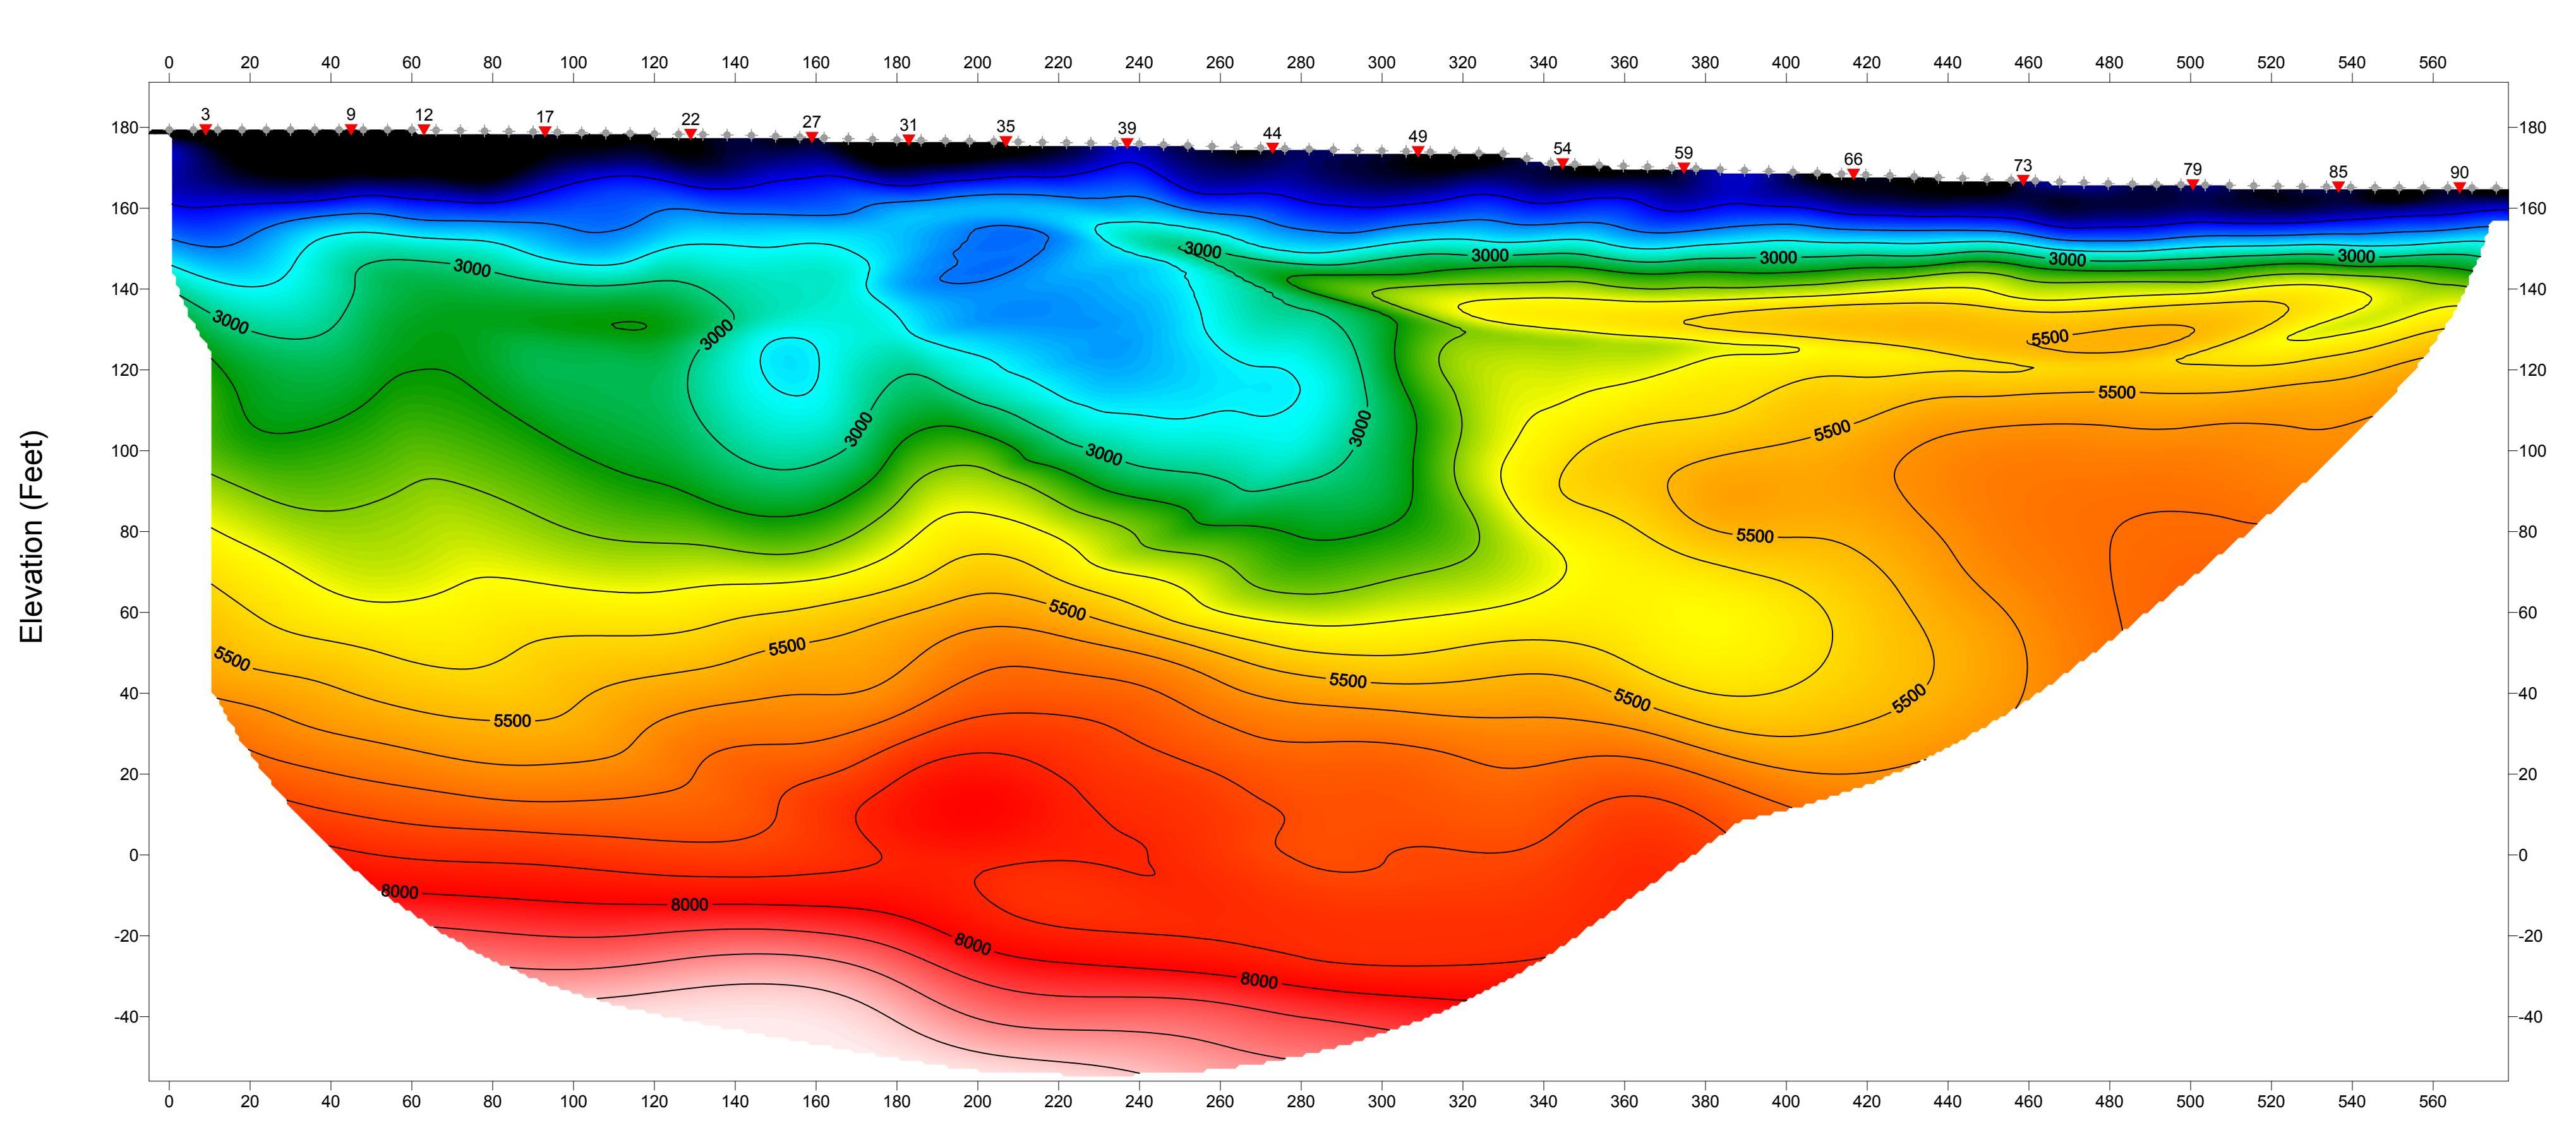
> Figure 5 Advanced Geoscience, Inc. March, 2016

The seismic field records from Lines 1-3 were also used to pick first arrival times ("first breaks") for refracted seismic waves traveling along the surface layer and the deeper higher-velocity layers. The travel time data from these first breaks were input together with geophone and source point x-coordinates and elevations into the computer program RAYFRACT written by Intelligent Resources, Inc. (Vancouver, Canada) to generate a velocity-depth model for Lines 1-3. RAYFRACT used the first break time picks to conduct refraction tomography imaging of the seismic velocity layering. An initial velocity-depth model was first estimated using the Delta-TV CMP velocity profiling procedure. This initial model was then refined to produce a closer fit to the first breaks using the Wavepath Eikonal Traveltime (WET) tomographic inversion method with 60 iterations. This best-fit, velocity-depth model was then gridded and color contoured with SURFER (Golden Software, Inc.) to show estimated vertical and lateral variations. The resulting velocity-depth profiles for Lines 1-3 are shown in Figures 5 and 6.

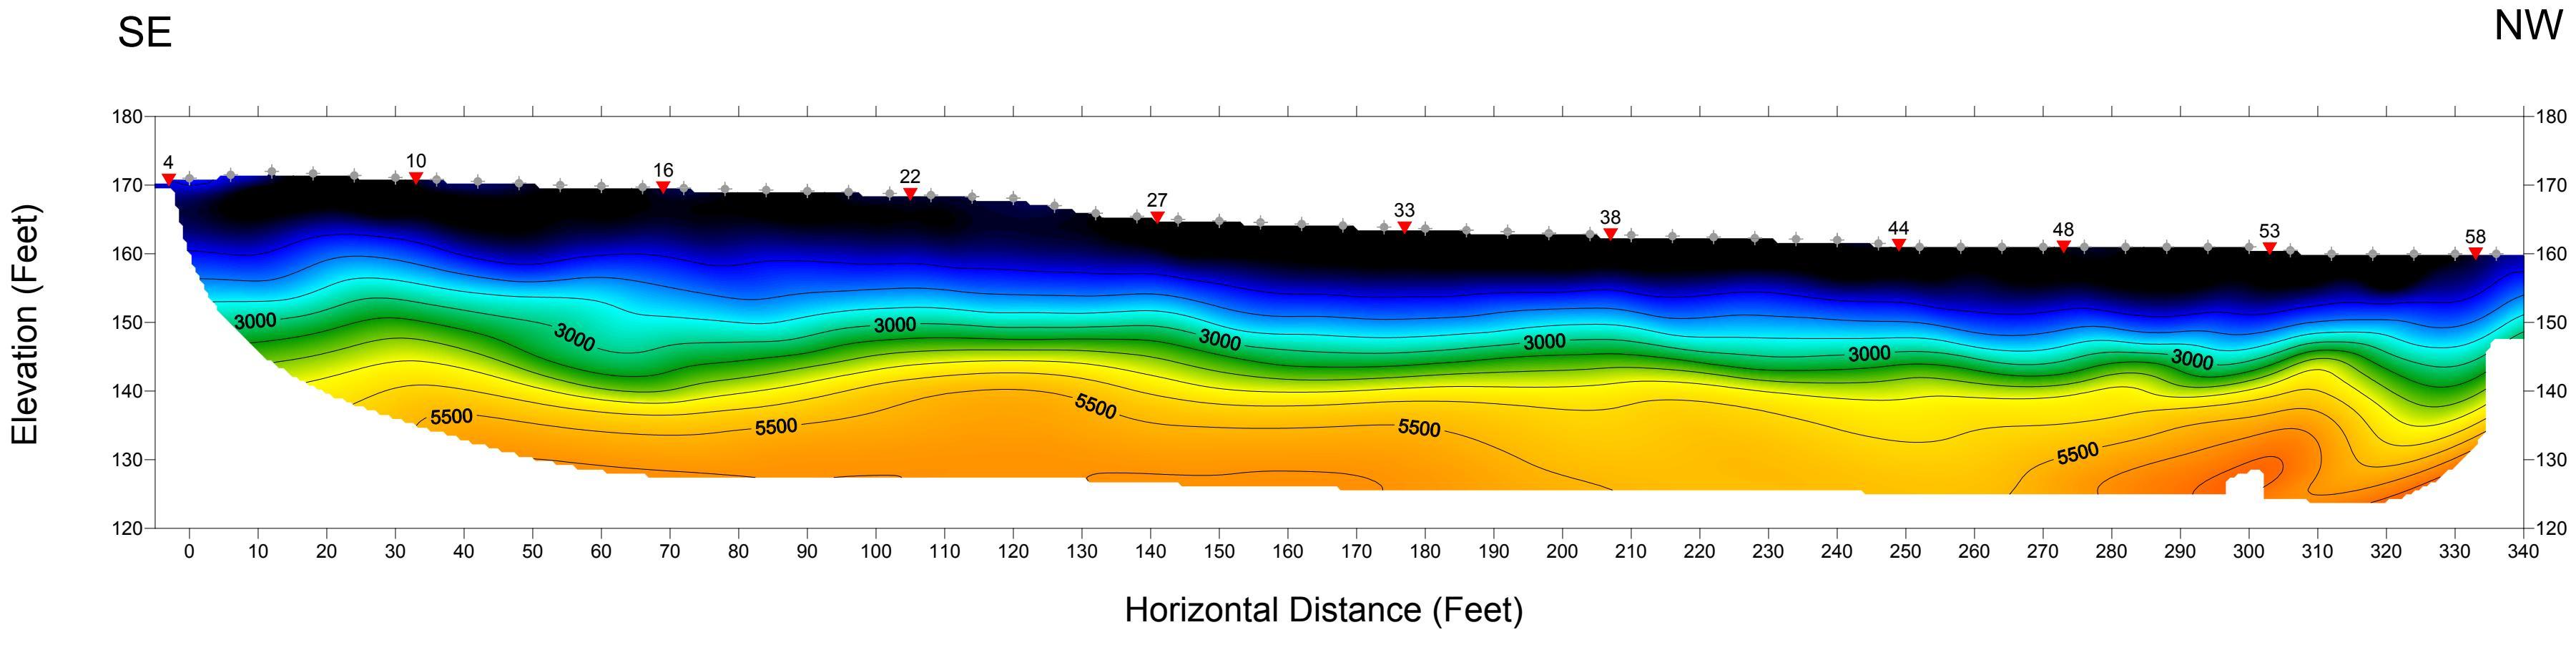
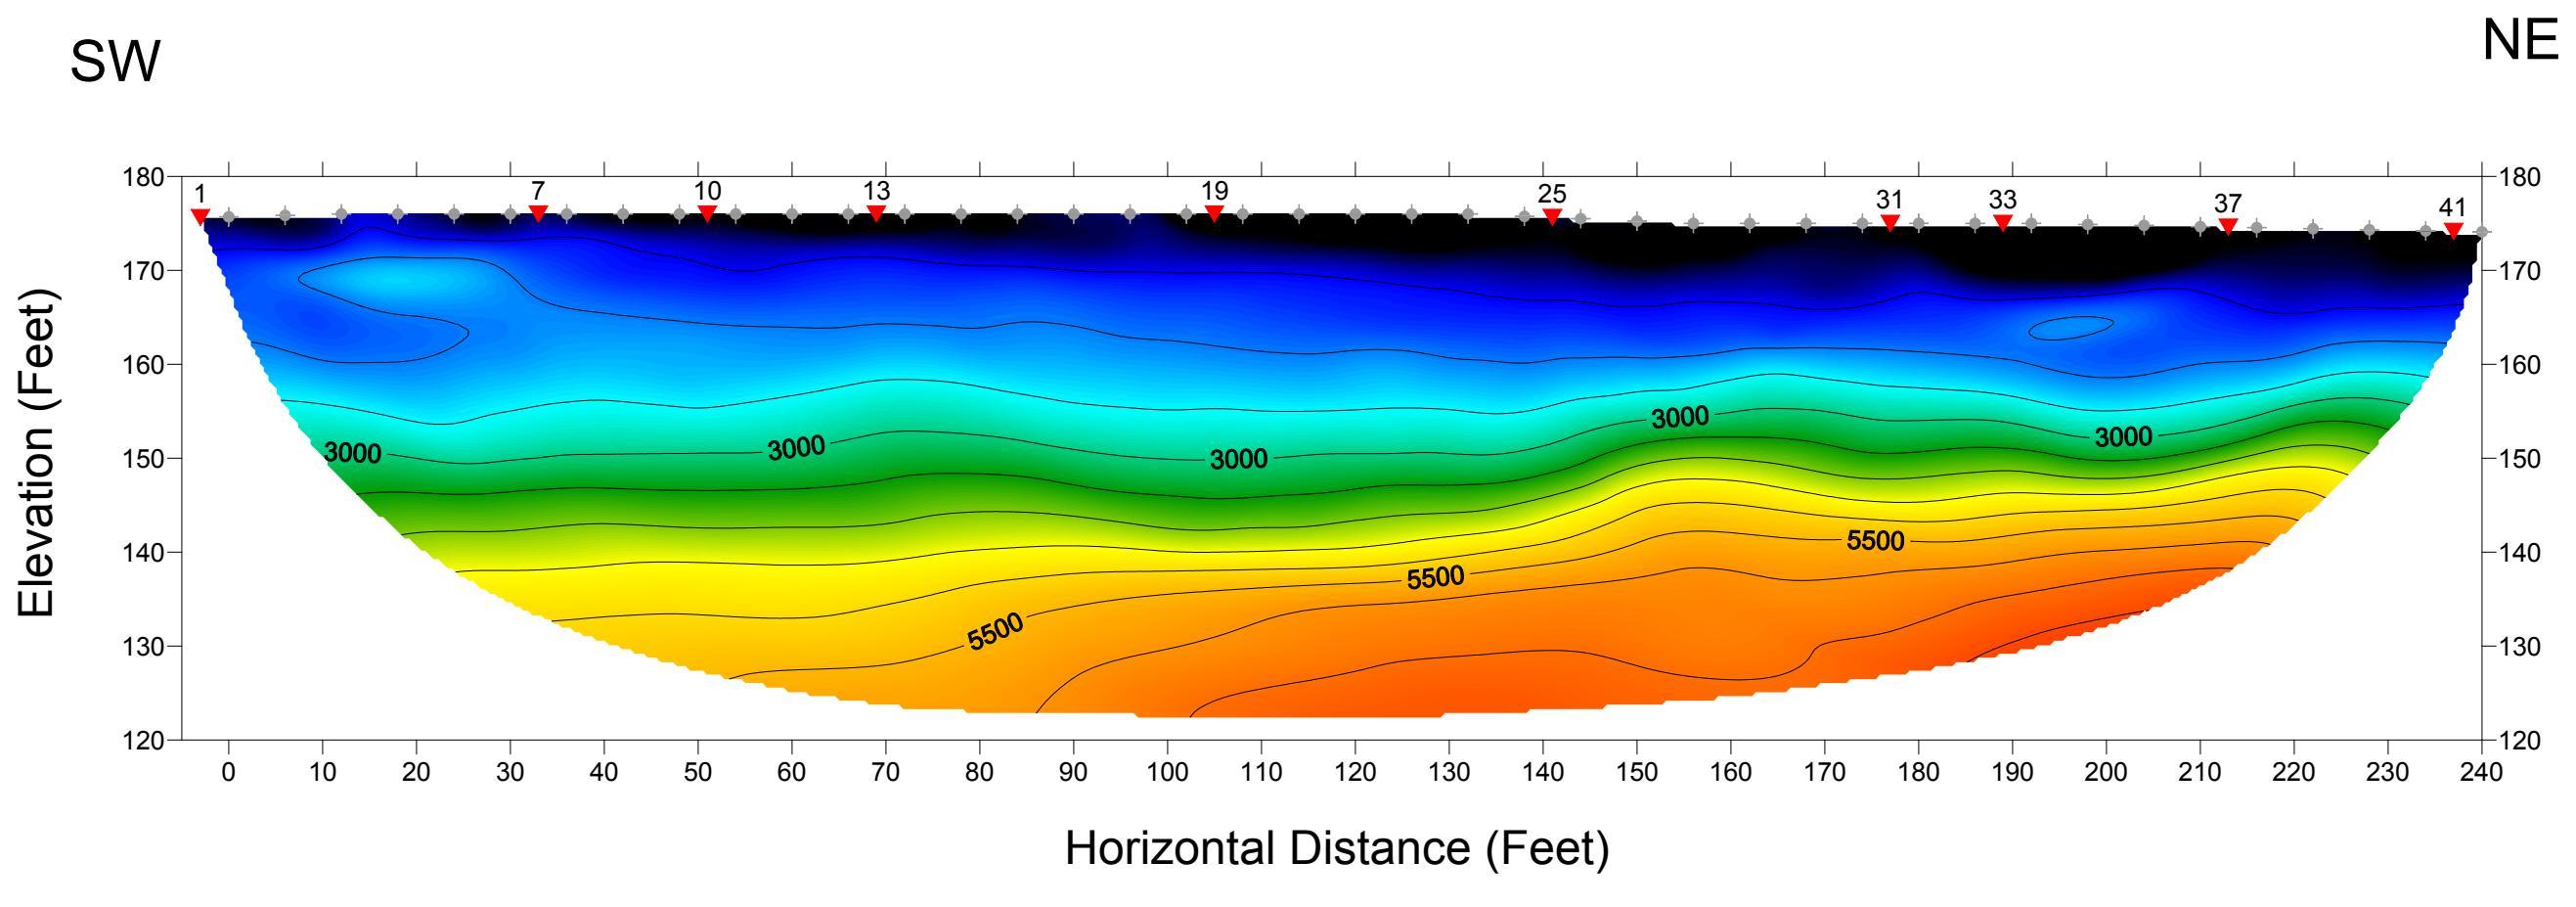
Figure 6 March, 2016

Lines 2 and 3 Seismic Refraction Velocity Depth Profiles Investigation of Subsurface Faulting Sansum Medical Facility Santa Barbara, California
